STAR ONLINE PUBLICATION

Case Number: S210800003 REV A.

Symptom/Vehicle Issue: Cluster Displays Blind Spot Alert Off Incompatible Trailer Message, Left Steering Wheel Switches Do Not Allow Update Or Change

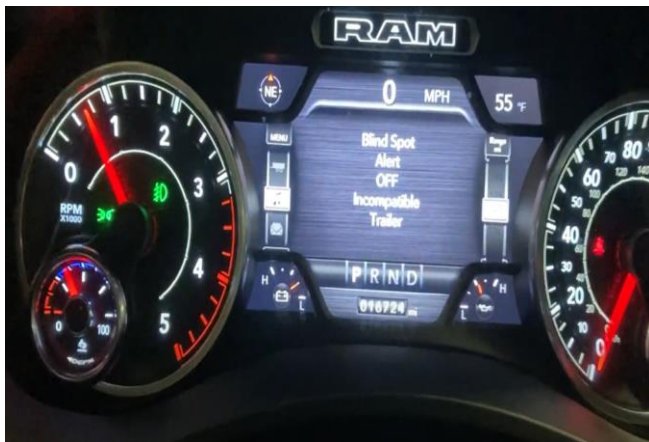
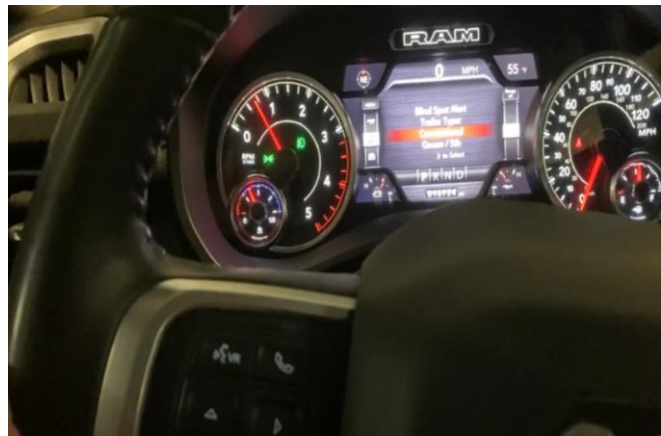
Repair Procedure: The Left and Right Blind spot sensors require trailer detection capabilities. Review a current scan report for the vehicle and ensure the sensors match the year of the vehicle they were intended for. Example below scan report 68358104AE is for 2019 vehicles and will not detect a trailer on a 2020 vehicle. Currently 2020 vehicles require 68442393AE. Replace the blind spot sensors to resolve.

LBSS	Left Blind Spot Sensor	CAN-I	68358104AE	Left and Right use the same part	68358104AE
RBSS	Right Blind Spot Sensor	CAN-I	68442393AC		68442393AC
