## STAR ONLINE PUBLICATION

**Case Number:** S2119000001

**Symptom/Vehicle Issue:** Click Pop Creak Noise While Turning Steering Wheel

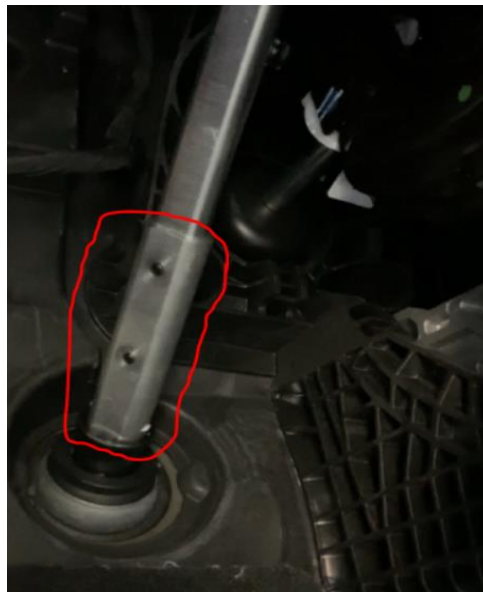
**Discussion:** For JL/JT and DT built before and MOPAR service columns packaged before 10/15/2020; use a stethoscope to listen to the lower steering shaft while the steering wheel is being turned. Fig 1 shows the dust cover removed to show the energy absorbing slip joint of the steering shaft on the interior side near the front bulkhead. Listen to the joint with the engine running and off. If the noise is originating from this area replace the steering column. The energy absorbing joint is not designed to be serviced or repaired other than replacement as a column assembly.

Fig 1 Steering shaft at the front bulkhead (interior side)
