STAR ONLINE PUBLICATION

Case Number: S2023000019 Rev A.

Symptom/Vehicle Issue: Noise From Headliner Roof Area

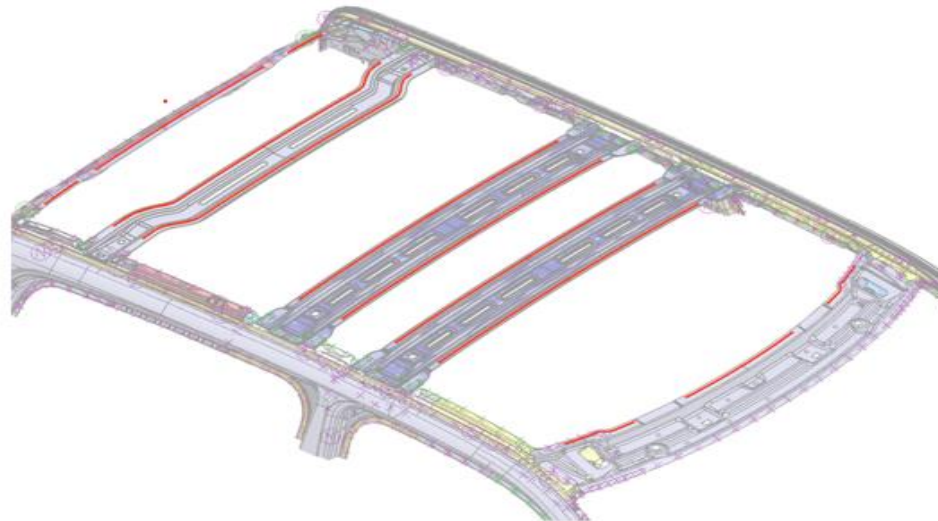
Discussion: A rattle or buzz noise complaint from above the drivers head could be a separated roof anti flutter foam joint. Once the complaint is verified, proceed to the repair steps below.

1. Removal of headliner. Refer to Service Information in TechCONNECT. 23 - Body / Interior / HEADLINER / Removal and Installation.
2. Inspect the roof bow foam for separation. See red line locations below.

3. Inspect for loose or missing foam. Remove any loose pieces. Remove foam from any areas that are not bonded to both surfaces.
4. Use MoPar Windshield Urethane 04864015AD or equivalent to fill the entire void. Ensure gap is filled between roof bow and roof panel. Use drop cloths and or tape to prevent urethane from contacting other interior areas. Follow curing instructions on the urethane kit.
5. Reinstall headliner and interior. See 23 - Body / Interior / HEADLINER / Removal and Installation.
