STAR ONLINE PUBLICATION

Case Number: S1708000013 REV. A

Symptom/Vehicle Issue: Key Cannot Be Removed From Ignition

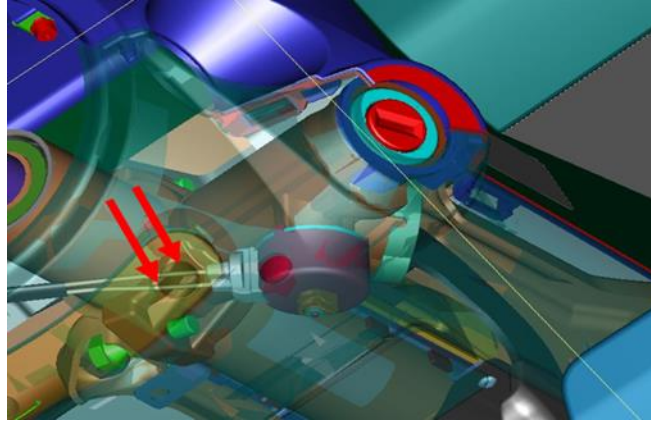
Figure 1. Position of the Key Lock Solenoid

- Verify voltage at the Key Lock Solenoid when the lever is moved to "PARK" (ensure the Park is lit on the bezel) and at Key Off (always in Park position).
- To verify the voltage disconnect the key lock connector and measure the voltage at the 2 pins of the vehicle side connector. See next page.

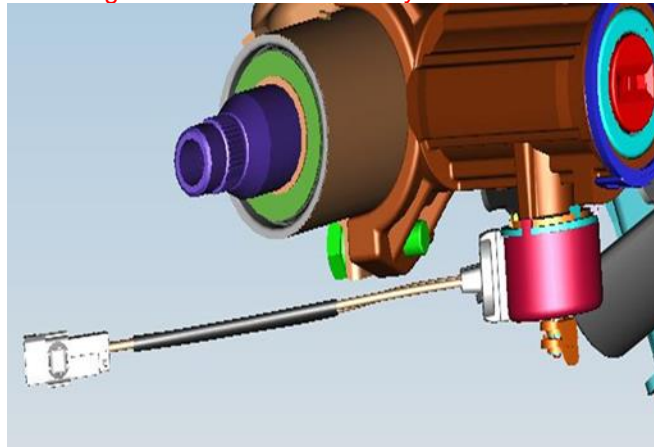
Fig 2. Key Lock Solenoid and its wire harness

- The voltage when key coil is fed (Park and Key Off) must be **V-BATT**
 - For all other lever positions, the voltage will range **from 0 to 0.5** Volts (Figure 3 and 4)
 -
- A. If the voltage readings match what is indicated above, then shifter is properly feeding the key lock solenoid and the issue is not related to the shifter:
- a. Check wire-harness up to Ignition Switch
 - b. The Key Lock Solenoid in Ignition may be overheated/damaged → Replace Key Lock Solenoid
