STAR ONLINE PUBLICATION

Case Number: S202500005 REV. A

Symptom/Vehicle Issue: Malfunction Indicator Lamp (MIL) Illumination. Diagnostic Trouble Codes P0407 – EGR Sensor B Circuit Low, or P0408 – EGR Sensor B Circuit High Set

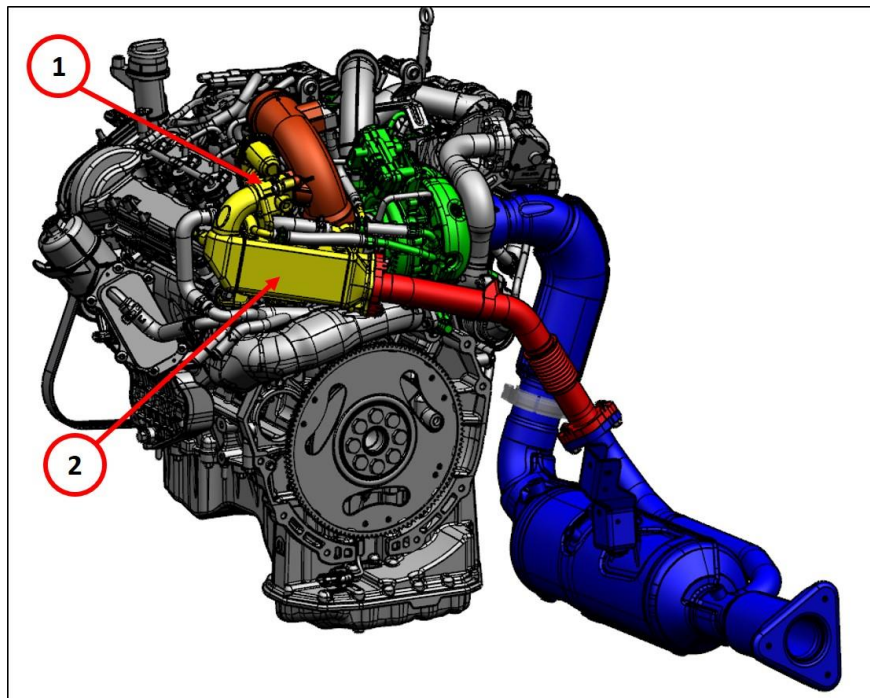
Figure 1

Please refer to (Figure 1) for the location of the LP EGR system.

1. LP EGR Valve.
2. LP EGR Cooler.
