STAR ONLINE PUBLICATION

Case Number: S2018000001 REV. A

Symptom/Vehicle Issue: Malfunction Indicator Lamp (MIL) Illumination. Diagnostic Trouble Code (DTC) P26FB – EGR Cooler Bypass Control Stuck Closed Bank 1 Set.

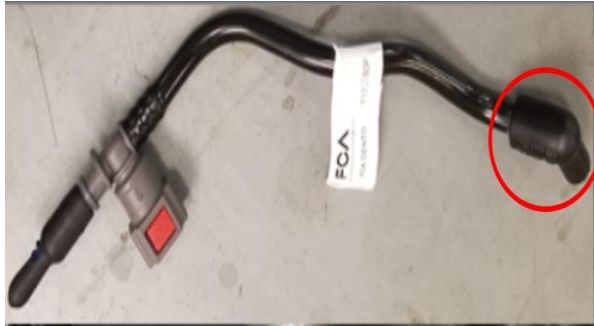
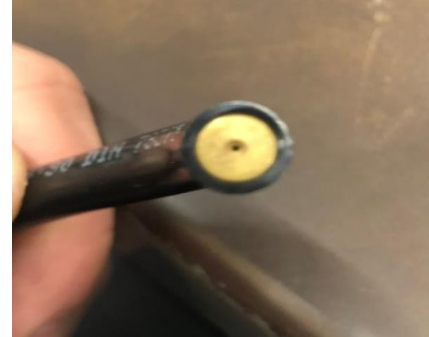
NOTE: There is a .6mm brass orifice in the vacuum tube assembly at the elbow connection. Some resistance in air flow is normal (See Fig. 2 and 3).

3. Carefully inspect the vacuum tube for the presence of a blockage in the orifice. This can be done by attempting to blow light air pressure through the tube assembly.
4. If the orifice in the tube is found blocked, please replace the tube assembly. **DO NOT** attempt to remove the blockage.
5. Inspect the internal integrity of the bypass valve by performing the following steps:
 - a. Gain access to the bypass valve vacuum actuator, and using your thumb, actuate the actuator in and out. (See Fig. 4). Ensure that the valve operates smoothly without sticking.
