STAR ONLINE PUBLICATION

Case Number: S2108000026

Symptom/Vehicle Issue: Cooling Fan Runs At High Speed. PHEV Battery Charges Slowly Due To Kinked Coolant Hose

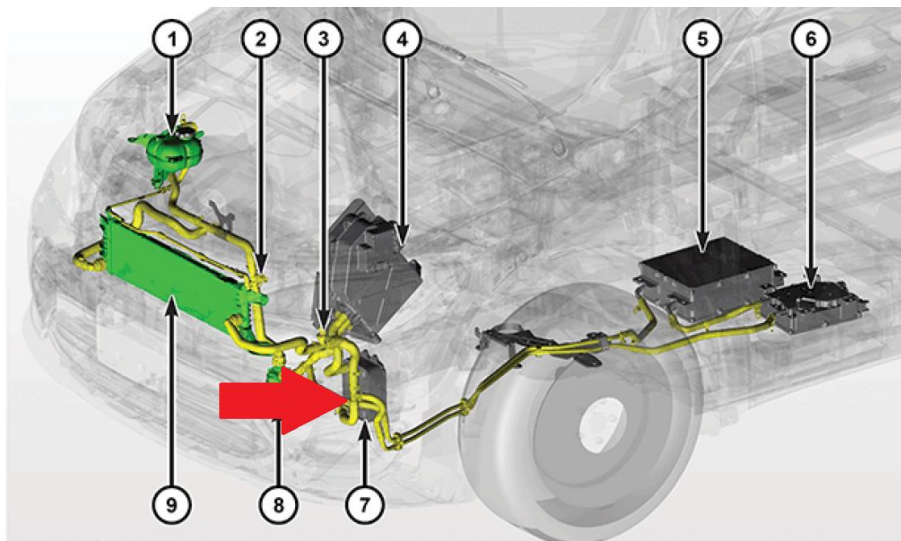
Discussion: The customer may complain of slow charging times and high cooling fan speeds when attempting to charge the High Voltage battery. A kinked hose in the Power Electronics Coolant Loop leading to the OBCM and APM may cause a coolant flow restriction and high OBCM temperatures. Consequently, slowing down the rate of charge and commanding the cooling fans to High. There are no DTC's associated with this issue.

Diagnosis: Inspect the Power Electronics Coolant Loop located behind the driver's front fender liner for kinks in the coolant hoses. The suspected hose is located near the T Junction.

Repair: Allow the vehicle to cool to reduce coolant temperature and normalize pressure. Relieve tension on the clamp for the coolant hose exhibiting the kink. Keep the hose on the aluminum coolant pipe to avoid coolant loss. Grasp the coolant hose and twist it to remove the kink.

If large quantities of coolant leak out when removing the kink. The Power Electronics Coolant Filling and Bleeding procedure will need to be performed.

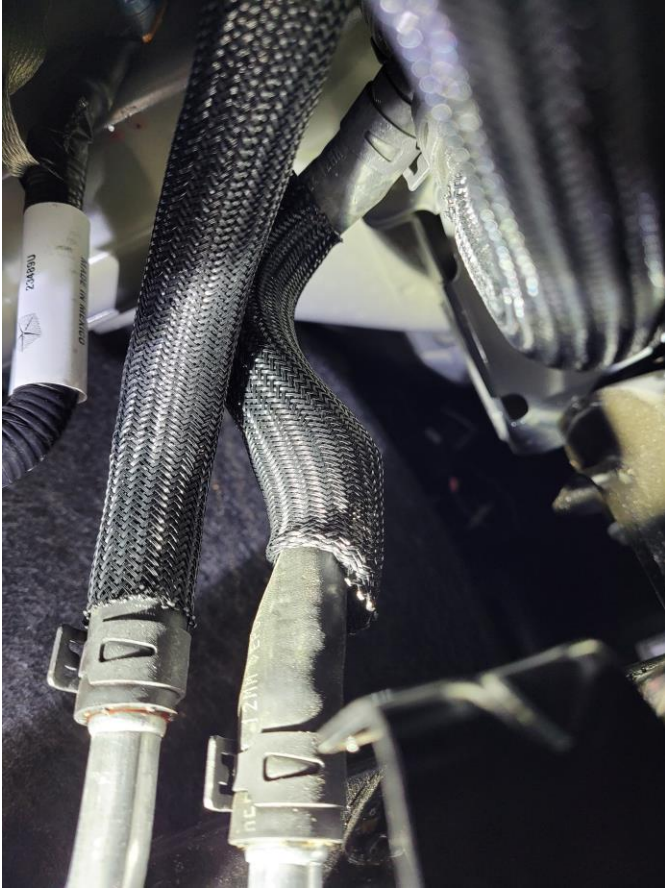
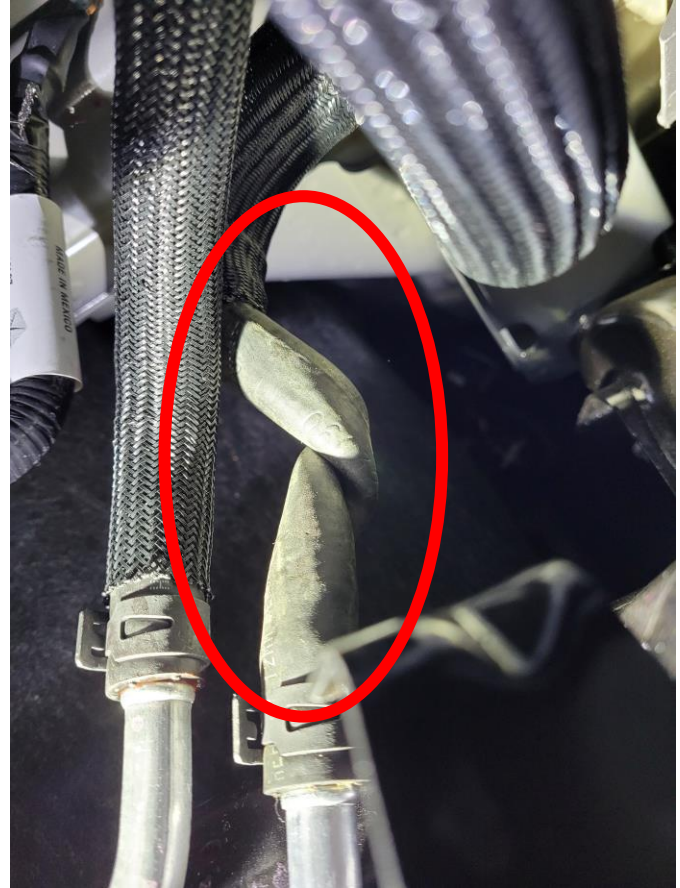
As seen above. The abrasion resistance sleeving may need to be pushed back and away to expose the kink.
