NUMBER: 08-002-21

UAQ and UCQ Radio Over the Air Software Version Updates

2020 (MP) Jeep Compass

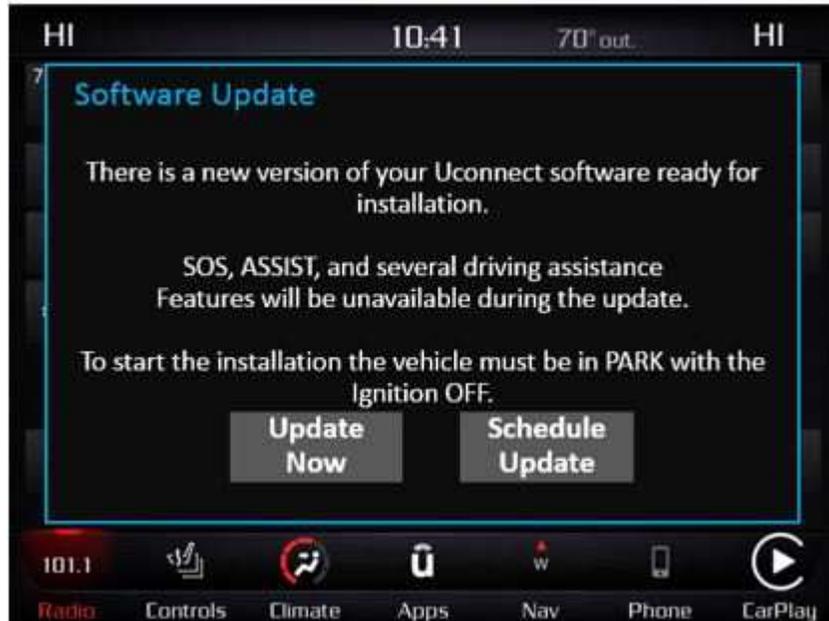
Fig. 1

Customers will see a notification on their radio screen when new software is available for their radio (Fig. 1). The owner will have the option to update the radio or schedule the update for later. **There is not an option to decline the update indefinitely, the update must be performed.**

Software Acceptance Screen

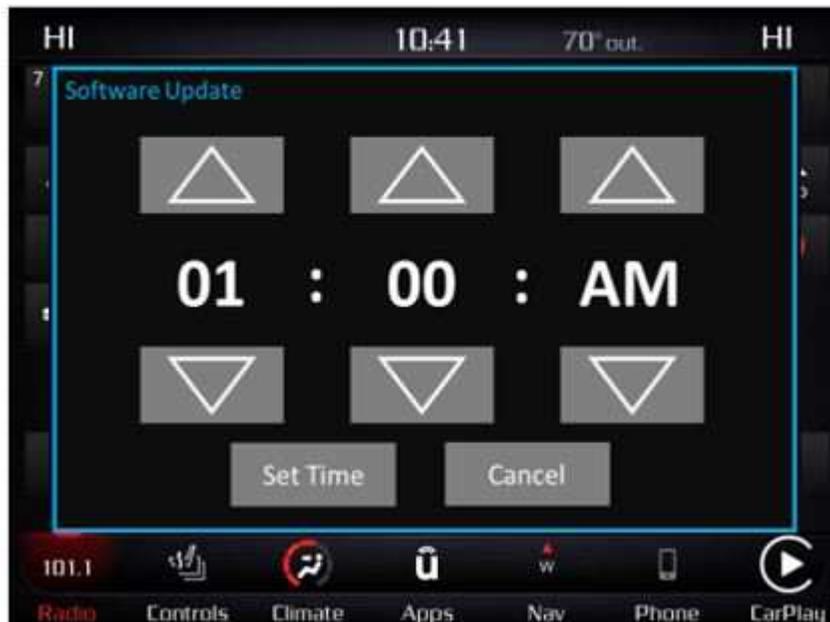
Fig. 2

NOTE: If selecting "Schedule Update" the screen below will be displayed. The customer can select the exact time they want the update to begin (Fig. 2).

Schedule Update Screen

1. The vehicle transmission needs to be in the park position, or have the vehicle in neutral with parking brake engaged if equipped with a manual transmission. The ignition needs to be off.
2. Whether the customer selects "Update Now" or "Schedule Update" (Fig. 2) and sets a time,

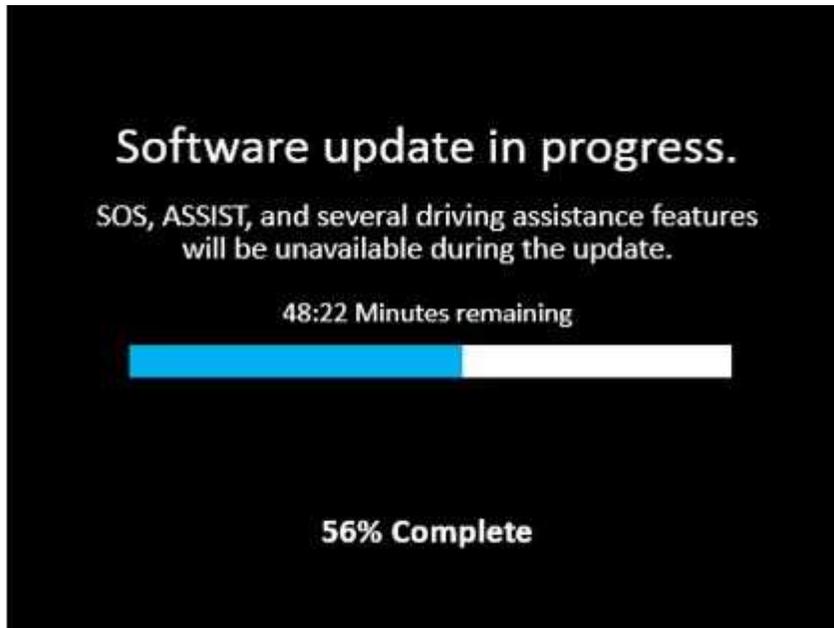
they can shut off the vehicle and leave. The update will be completed automatically (Fig. 3) .

Fig. 3
Update In Progress Screen

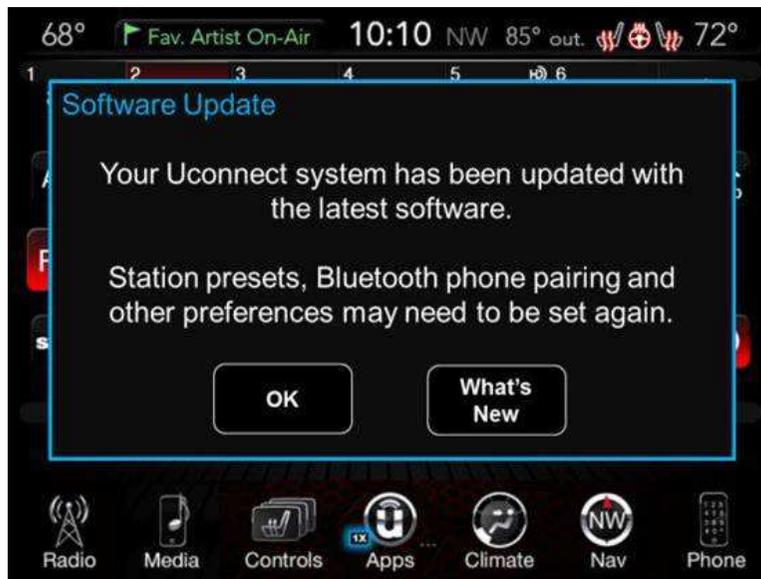
3. Upon completion of update, the radio will display a confirmation message (Fig. 4) .

Fig. 4
Update Confirmation Screen
