**NUMBER:** 23-004-21

Third Row Sunshade Will Not Close

2020	(RU)	Chrysler Pacifica
------	------	-------------------

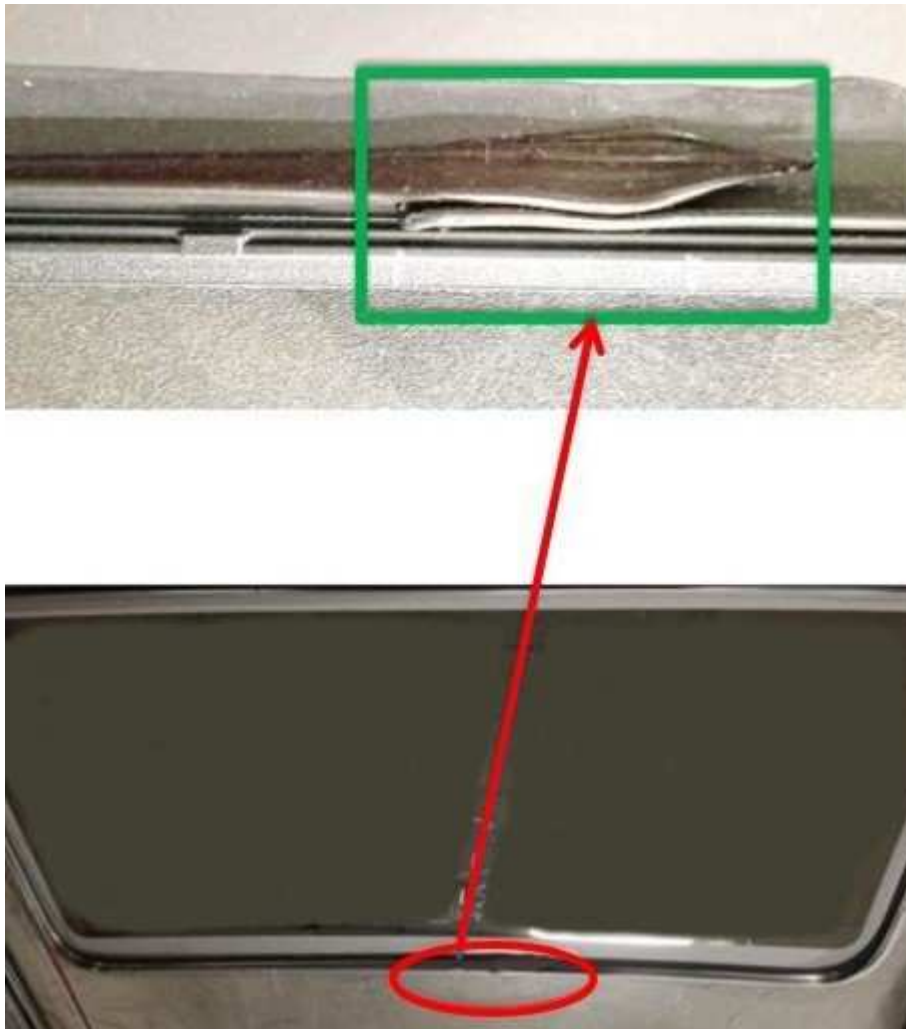
**Fig. 1**

**NOTE:** This condition is caused from excess urethane, bonding the sunshade edge to the sunroof glass.

**Location Of Excess Urethane On Sunshade Leading Edge**

- The headliner and sunshade do not need to be lowered, or removed from the vehicle to perform this Repair Procedure.
  - If necessary, position the third row seats for better access.
1. From inside the vehicle and using hands, carefully and steadily pull/tug the front leading edge of the sunshade plastic trim, away from the headliner excess urethane (Fig. 1) .

2. Close and open the sunroof sunshade to check operation. The sunshade should now be free, if not further diagnosis may be needed.
