**NUMBER:** 24-001-21 REV. A

Air Conditioning Line Crimp Failure

2020 - 2021 (M1) Jeep Compass

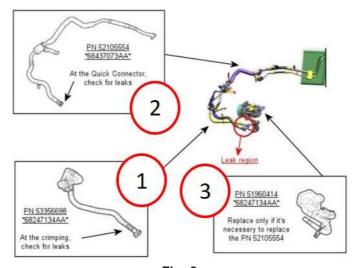
Fig. 2
Check Connections And Line Replacement

- 1 A/C Discharge line (flexible pipe)
- 2 A/C Suction line (flexible pipe)
- 3 A/C Suction and Discharge jumper (rigid pipe)
- 2. Replace the A/C Suction line (flexible pipe) (Fig. 2). Refer to the detailed service procedures available in DealerConnect> Service Library under: Service Info>24 Heating and Air Conditioning/Plumbing/Line, A/C Suction/Removal and Installation. Proceed to the next step.

1. Replace the A/C Discharge line (flexible pipe) (Fig. 2) . Refer to the detailed service procedures available in DealerConnect> Service Library under: Service Info>24 - Heating and Air Conditioning/Plumbing/Line, A/C Discharge/Removal and Installation.

- 3. Replace the A/C Suction and Discharge jumper (rigid pipe) (Fig. 2). Refer to the detailed service procedures available in DealerConnect> Service Library under: Service Info>24 Heating and Air Conditioning/Plumbing/Assembly, A/C Suction and Discharge/Removal and Installation. Proceed to the next step.
