STAR ONLINE PUBLICATION

Case Number: S2123000060

Release Date: Aug 2021

Symptom/Vehicle Issue: 3rd Row Headrest Not Folding When Seat Fold Is Selected From The Radio Screen Soft Button Or Handle.

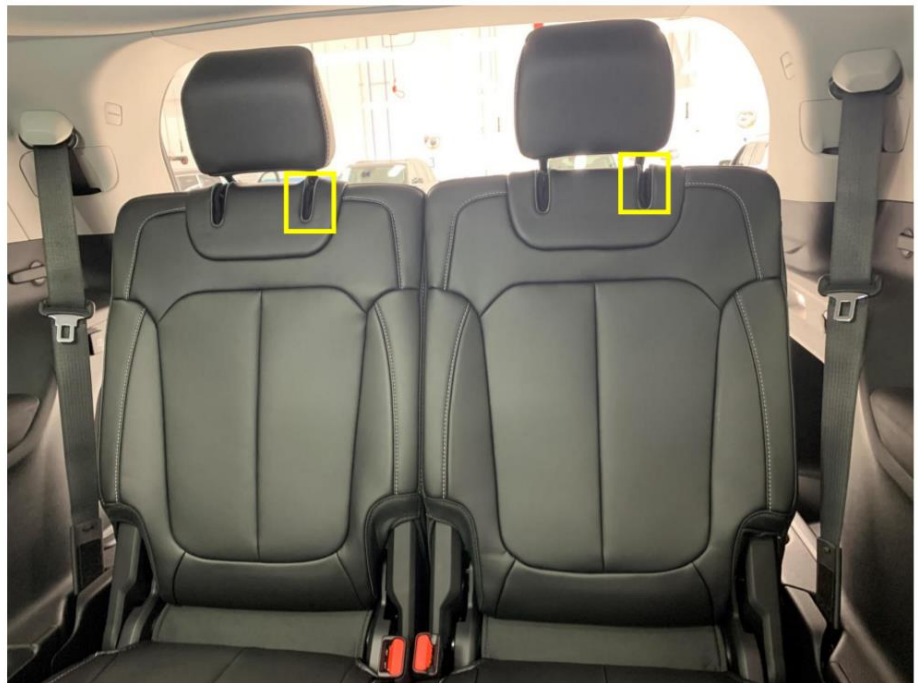
3rd Row Head Rest Inspection, looking at seat set from the front:

1. Visually inspect (use flashlight) for proper installation of the HR release clip by examining the mechanism through the trim cutouts for both 3rd row seats (see picture).
 - The embroidered trim opening and carpet beneath can both be manipulated in order to better view the internals
2. Ensure clip is properly seated (descriptive images on following slides)
3. If partially seated or not seated, repair using procedures on the following slides.

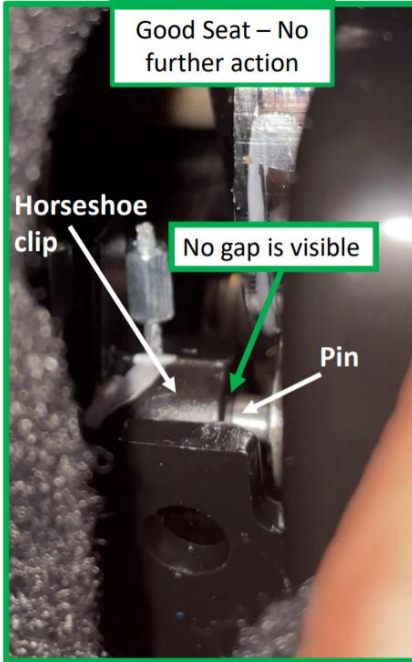
Horseshoe clip fully installed

Good Seat – No further action

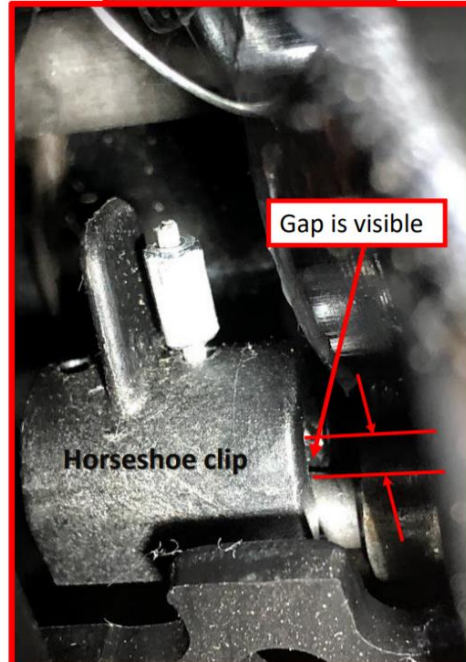
A) Horseshoe clip not fully seated: See page 3

1. Pull forward on the HR using moderate force to stop headrest from folding during clip install
2. Push down on the fin of the horseshoe clip until it snaps in
 - 6-10 lbs of force to snap in
3. Test the mechanism for proper functionality – cycle the rear fold handle and/or the power actuator
 - Finesse trim at headrest posts as required

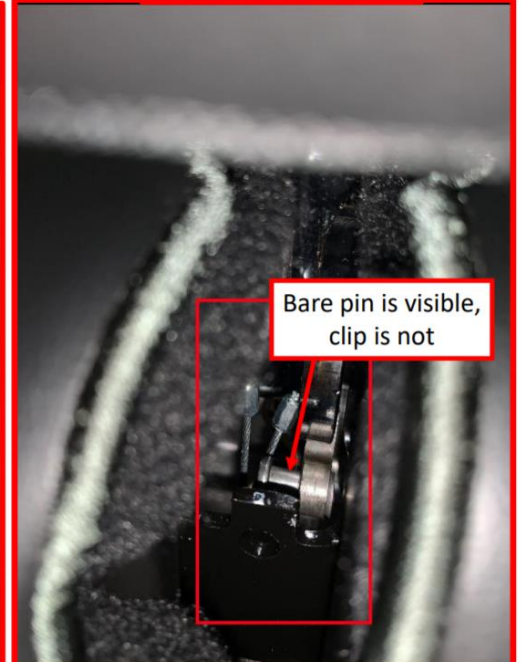
B) Horseshoe clip not visible: See page 4

1. Unzip the seatback trim cover (using zipper tool or needle nose), unfasten bottom J retainer & Remove fir-tree clip (if present) at rear which holds the front face of the trim cover

2. Pull the trim cover and foam pad assembly forward until structure is accessible
3. From the front of the seat, reach under front cover foam and locate horseshoe clip by following the cable conduit upward

- Push the clip upward inside the headrest bracket next to the headrest release pin
 - The clip opening must face toward the pin and the cables must not be twisted (2 cables on manual, 1 cable on power)

- Reach overtop & grasp the clip with your other hand
 - Position the horseshoe clip over the nail head pin
4. Pull forward on the HR using moderate force to stop the headrest from folding during clip install

5. Push down on the fin of the horseshoe clip until it snaps in
 - 6-10 lbs of force to snap in
6. Test the mechanism for proper functionality – cycle the rear fold handle and/or the power actuator prior to reassembly

- Tuck zippers and finesse trim at headrest posts as required
