STAR ONLINE PUBLICATION

Case Number: S2102000005

Release Date: August 2021

Symptom/Vehicle Issue: Slower Than Normal Raising Time And Or Failure To Achieve Desired Ride Height And OR Difference In Front Ride Height

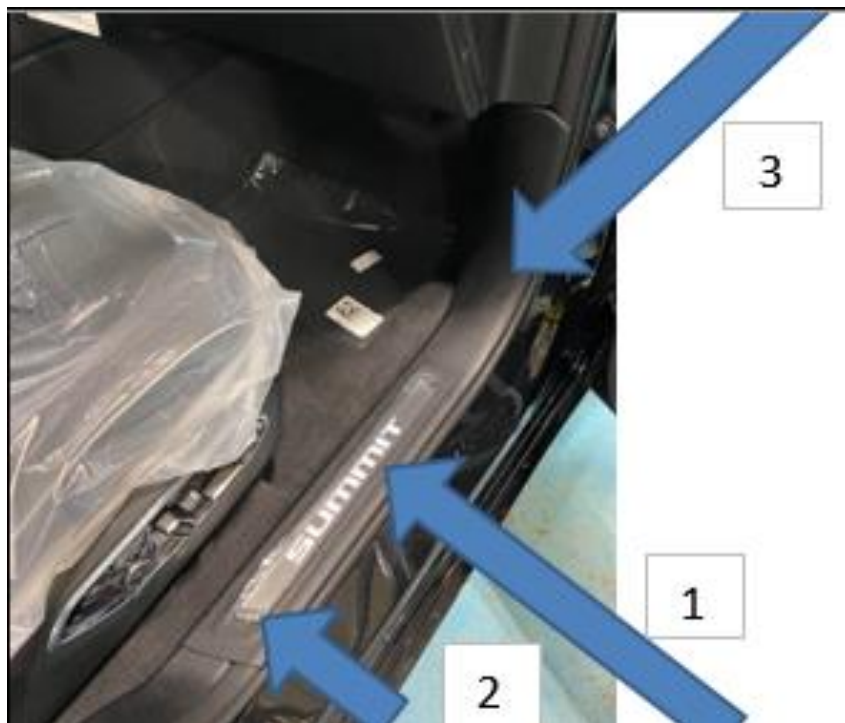
Fig 1 Kick plate trim removal

1. Passenger front carpet will need to be peeled back towards the center console. To accomplish this remove the kick plate trim at the bottom of the door jam. Using hands and trim stick, carefully slide fingers underneath the center flat portion of the trim. Lift up to pop 2 clips. Then on the left (rear facing side) end of the trim, Lift up there to pop remaining clips Finally, Pull gently rearward on the trim to pop out the final clips that begin to climb the A-Pillar area. Fig 1

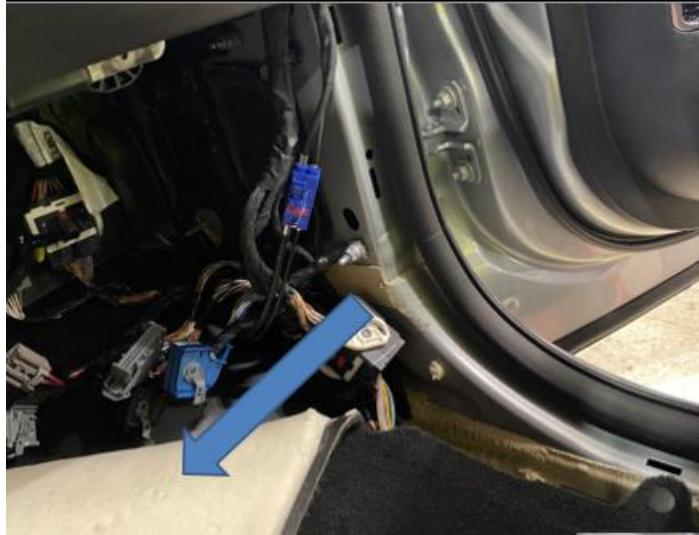
Fig 2
Carpet pulled towards center console.

2. Peel carpet towards the center console. Carefully pull the right corner of the carpet out of the way as shown in Fig 2

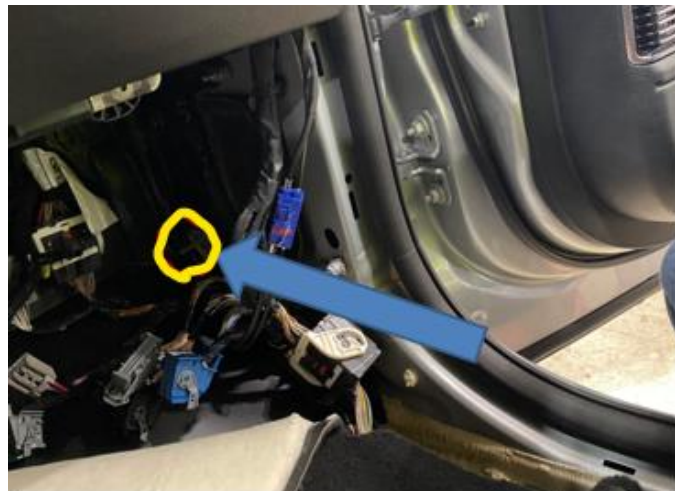
Fig 3

3. Inspect the circled area looking for the pinched line condition shown in Fig 3. Look for the air line to be trapped under the bcm lower attaching screw. If pinched in this location the line(s) (one or both) require replacement. Pinched air hoses should not be reused. The lines are serviced as a front airline bundle.

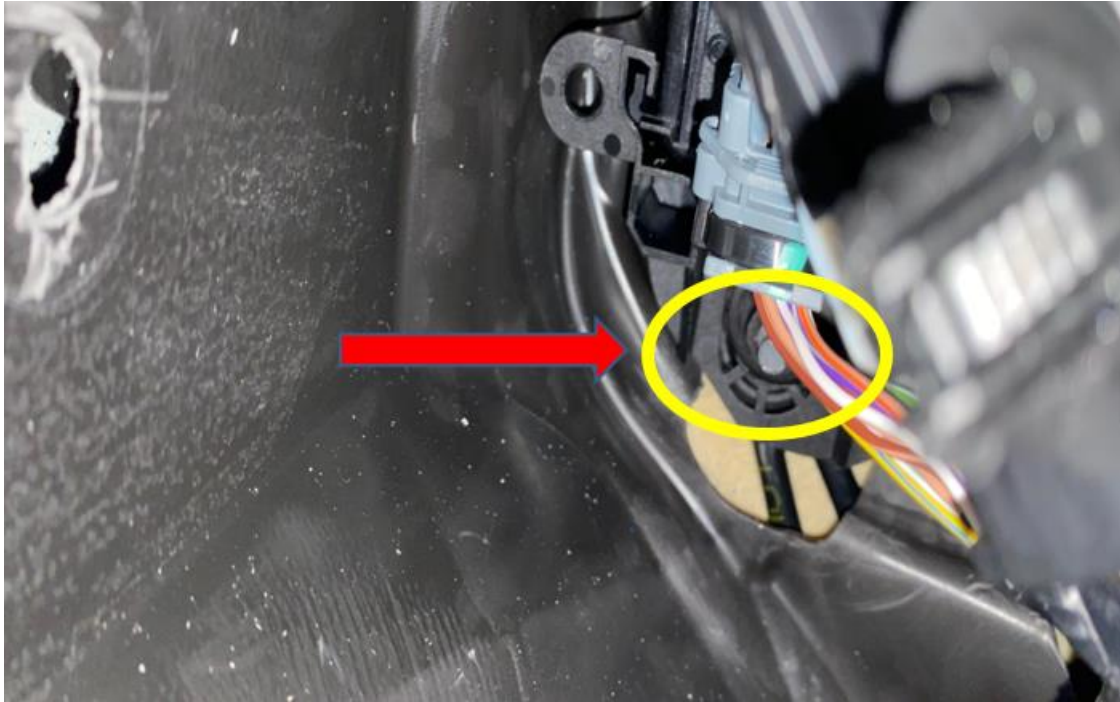
Fig 3a

Zoomed in closer. Yellow circle indicates the fastener that could pinch the tubing.

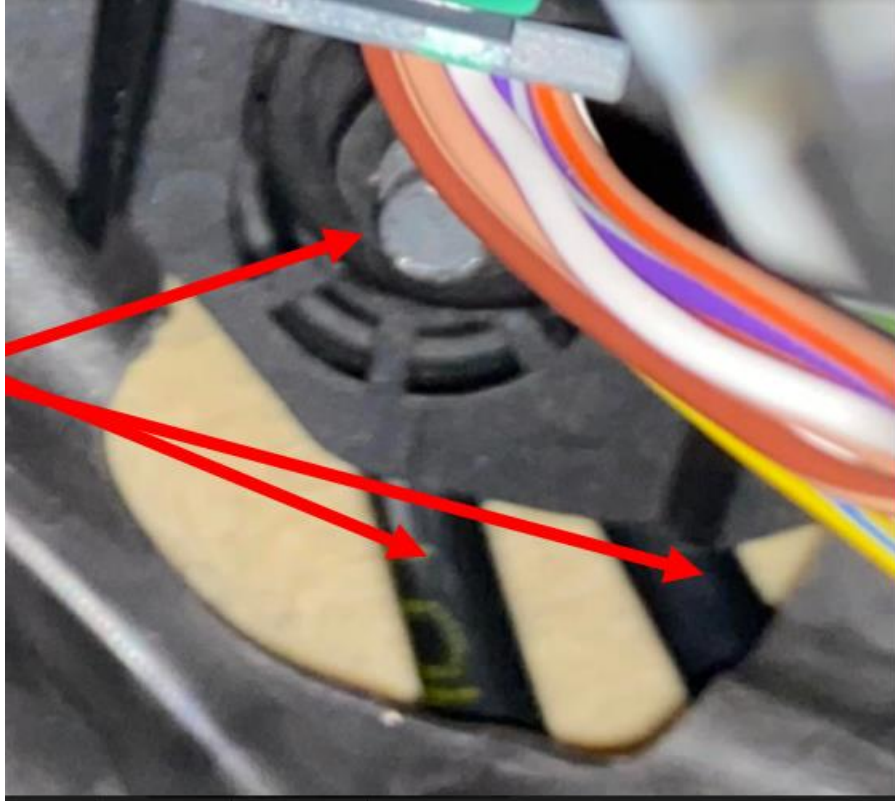
Fig 3b

Closer image of trapped air lines at fastener.
Red arrows point to tubing pinched.

Remove air lines from underhood area, de-trim passenger side interior and remove air lines. Remove air lines from Fast Down Level Valve and pull into interior. Install new air lines bundle in reverse order.

Note>>> When removing lines and components use masking tape to cover the ports and tube ends to prevent system contamination of dirt and or debris.
