STAR ONLINE PUBLICATION

Case Number: S2123000004

Symptom/Vehicle Issue: WL Front Control Arm Bushing - Handling Link Has Loose Rubber Appearance

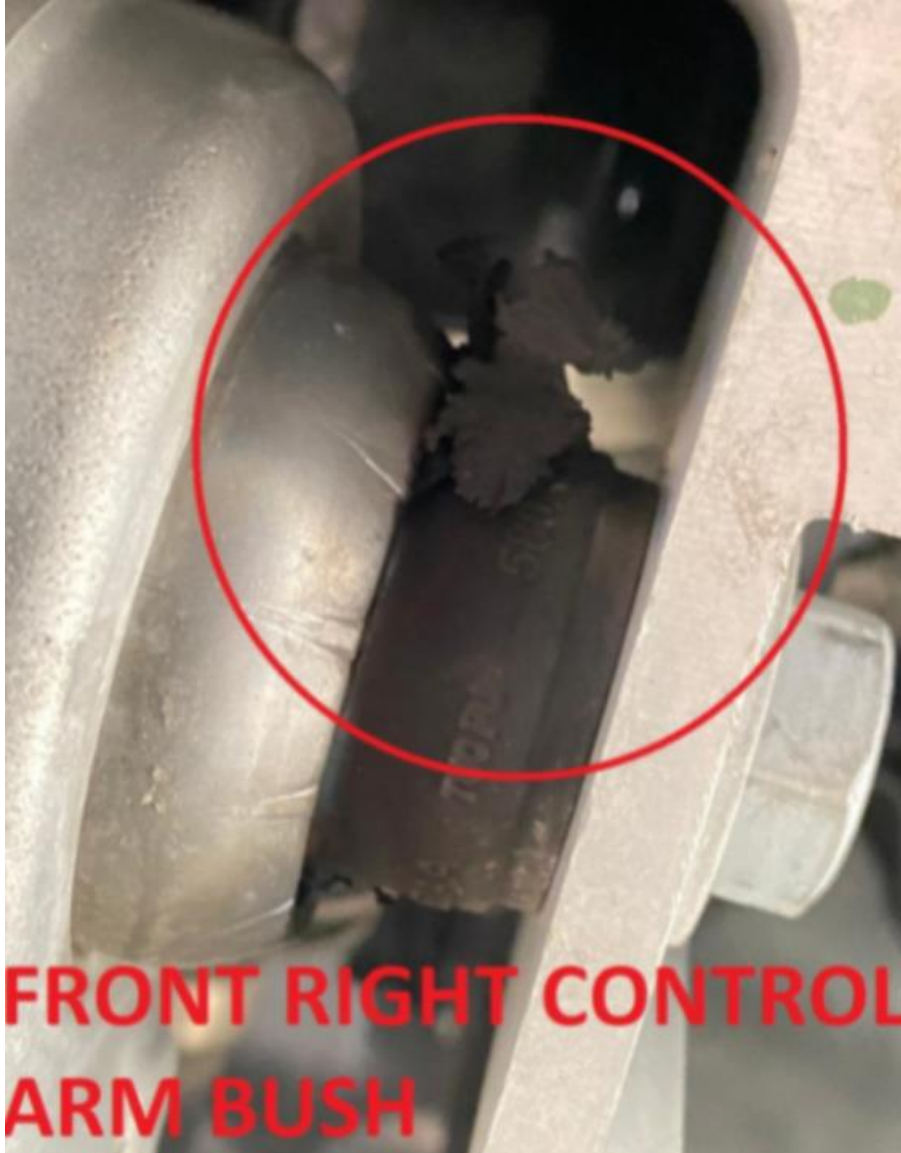
Discussion: The outer bushing sleeve has a rubber layer as part of the manufacturing process and is not an “active” part of the bushing. If the rubber from this outer surface has separated it does not require repair or control arm replacement. The condition does not affect the bushing operation or vehicle handling. See the image below.

Front Control Arm Bushing.
Condition present is deemed normal. No repair necessary.
