STAR ONLINE PUBLICATION

Case Number: S2123000068

Symptom/Vehicle Issue: Low Spot On Dash Cover Near Passenger Air Bag

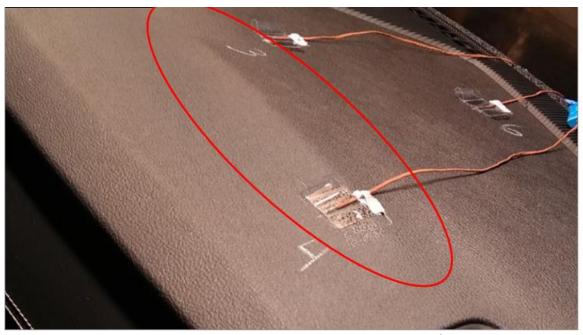
Customer Complaint/Technician Observation: After sitting in hot conditions such as bright intense sun the dash pad above the passenger air bag shows a sag or low area

Dash pad above passenger air bag has low/dip area

Discussion: The condition is the dash pad material softening in the intense heat (200+degrees F). Do not replace the dash for this concern as the replacement parts will exhibit the same visual low spot in the same heat conditions. Engineering is aware of customer complaints and investigating.
