## STAR ONLINE PUBLICATION

**Case Number:** S2108000194 REV. A

**Symptom/Vehicle Issue:** High Beams Do Not Turn On While The Headlamp Switch Is Set To The Auto Lights On Position, High Beam Headlamps Do Operate With Switch Set To Manual Lights On Low Beam Position

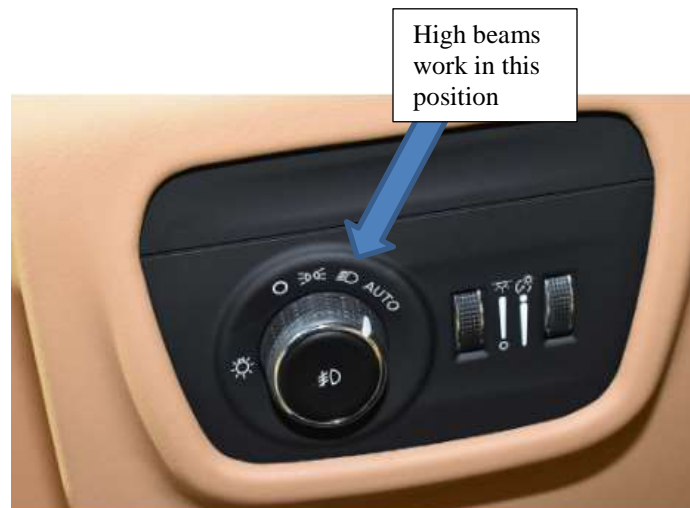
**Customer Complaint/Technician Observation:** Owner would like the high beam functionality to be available in both auto head lamp on position and manual head lamp on low beam position. Technician has validated the high beams do work as described above, but not at the owners desired position.

**Discussion:** No repairs should be attempted, engineering is currently investigating the operation of the high beams to be featured in multiple head lamp switch settings. The field will be notified with any updates to improve.
