NUMBER: 23-001-21 REV. A

Rear Glass Prop Rod Failure

This bulletin involves inspecting the rear backlite prop rod Julian dates and possibly replacing both prop rods.

2020 (JL) Jeep Wrangler

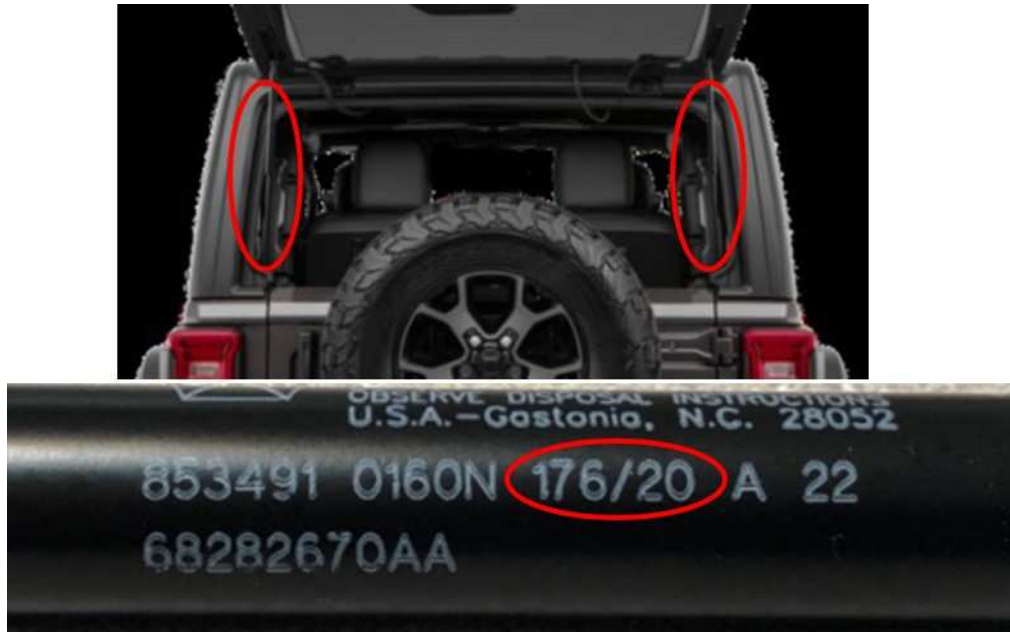
Fig. 1
Rear Prop Rod Julian Date

1. Open the rear backlite and inspect both rear glass prop rod Julian dates (Fig. 1) .

2. Are the Julian dates on the metal cylinders (Fig. 1) one of the following: **169/20, 174/20 or 176/20?**
 - YES>>> Replace the rear backlite prop rods. Proceed to [Step 1](#) of the Repair Procedure.
 - NO>>> This bulletin has been completed, use inspection LOP ****(23-40-29-98)**** to close the active RRT.

1. Replace both rear backlite prop rods. Refer to the detailed service procedures available in DealerCONNECT/Service Library under: Service Info>23 - Body / Decklid/Hatch/Liftgate/Tailgate/Swing Gate / Prop, Gas, Backlite / Removal and Installation.
