NUMBER: 08-131-21

GROUP: 08 - Electrical

Possible Water Intrusion at the P1 and P2 High Voltage (HV) Connectors

2021 (JL) Jeep Wrangler

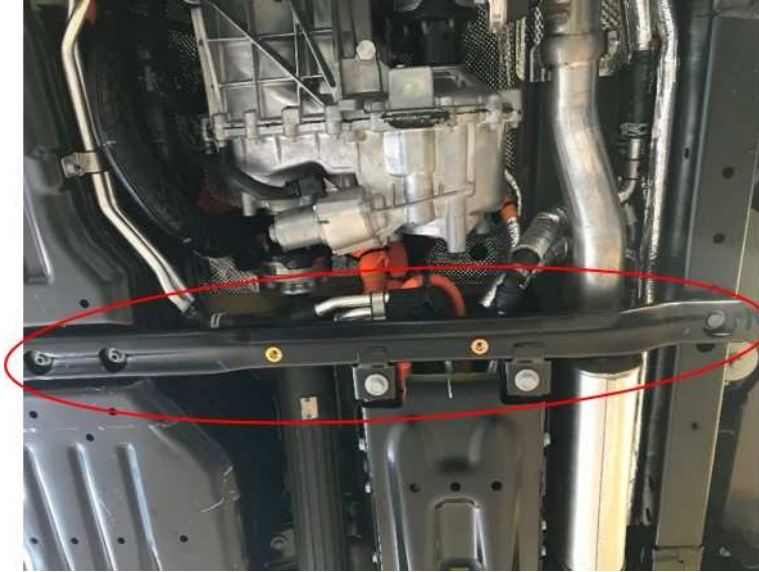
Fig. 1

Cross Member Bar

3. Remove the skid plate located under the vehicle protecting the transfer case. Refer to the detailed service procedures available in DealerCONNECT> Service Library under: Service Info>13 - Frame and Bumpers / Under Body Protection / Plate, Skid / Removal and Installation>Transfer Case.
4. Remove the cross bar member (Fig. 1) .

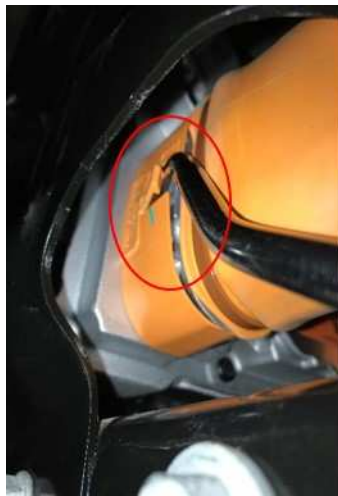
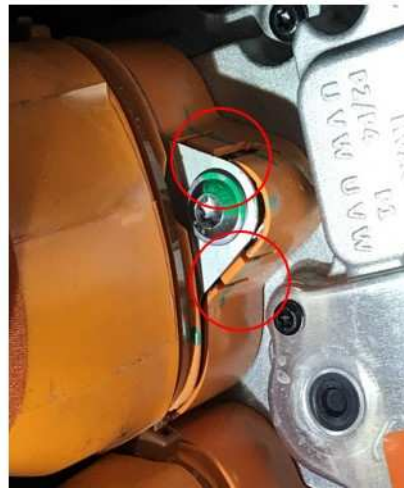
Fig. 2

Shroud Tabs

5. Remove both P1 and P2 orange shrouds. Use long pick tool to break and remove the shroud (Fig. 2) .

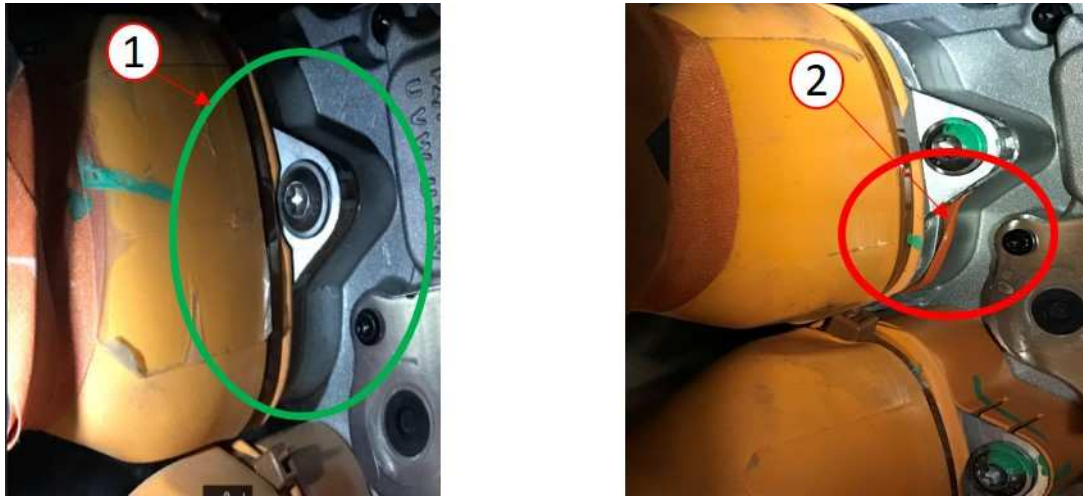
Fig. 3
Seal Location

- 1 - OK
- 2 - Not OK

- 7. Is the orange seal pinched or not properly seated on either the P1 or P2 connector (Fig. 3) ?
 - YES>>> Proceed to Step 1 of the Repair Procedure.
 - NO>>> Proceed to Step 8 of the Inspection Procedure.
- 8. Verify the connectors are fully seated and not on an angle.
- 9. Are the connectors not at an angle and fully seated with a torque of 9 N·m (80 in .lbs.) for both the P1 and P2 connectors?
 - YES>>> This bulletin has been completed, use inspect LOP (08-90-13-90) to close the active RRT. Proceed to Step 11 of the Repair Procedure.
 - NO>>> Proceed to Step 7 of the Repair Procedure.

- 6. Verify there is no pinched seal around both connectors and interface mating lines. Use a mirror and flashlight to ensure proper visual inspection (Fig. 3) .

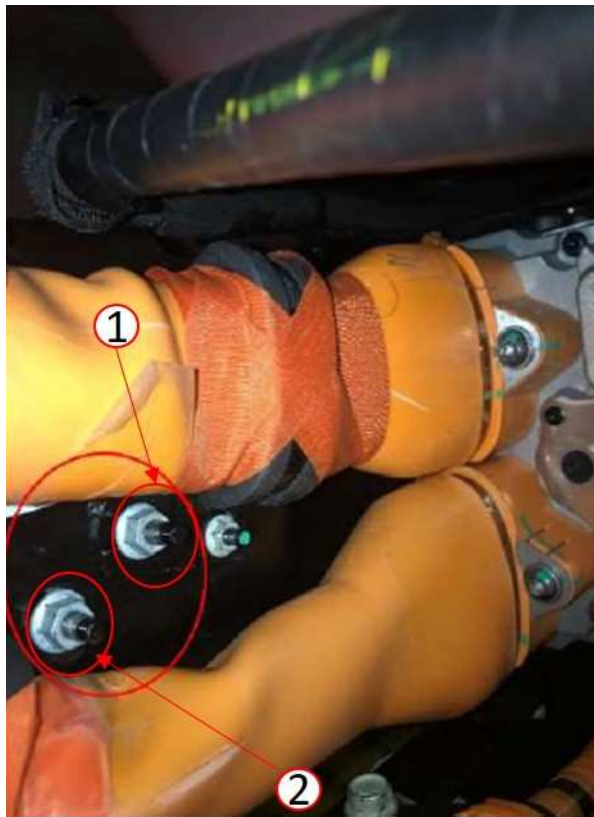
Fig. 4
P1 and P2 Bracket Nuts

- 1 - P2 Bracket Nut
2 - P1 Bracket Nut
-

1. Remove the 10 mm nut securing the P1 and/or P2 bracket (Fig. 4) .

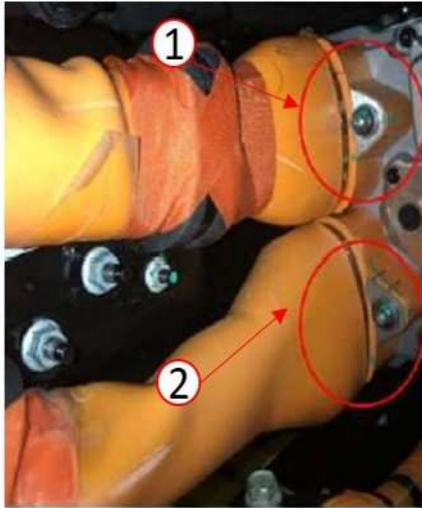
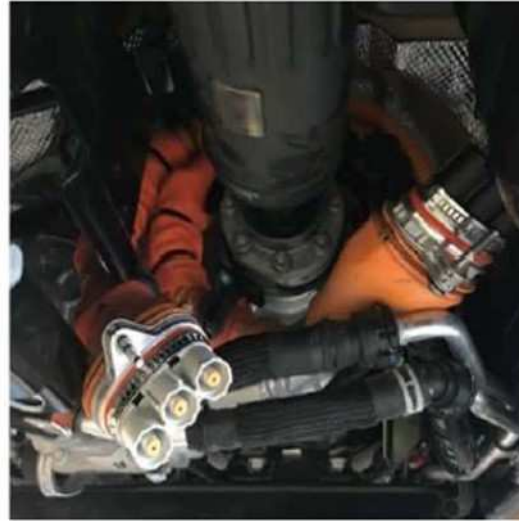
Fig. 5
Connector bolts

1 - P2 Connector
2 - P1 Connector

NOTE: If corrosion is present, the harness and/or Power Inverter Module (PIM) will require replacement, follow published service procedures as those components are not part of this RRT repair.

2. If the P1 connector orange seal is showing, loosen the P1 connector bolt, disengage the connector, and pull the connector back (below super module skid plate) (Fig. 5) . Repeat this step if P2 connector orange seal is showing (Fig. 5) .

- If corrosion is present, use inspect LOP (08-90-13-90) to close the active RRT.
 - If no corrosion is present proceed to [Step 3](#) and continue with the repair.
3. Remove any moisture that may be present and has not cause any corrosion to the connectors.
