NUMBER: 07-001-21

GROUP: 07 - Cooling

Transmission Oil Cooler Lines Not Fully Engaged

2021 (JL) Jeep Wrangler

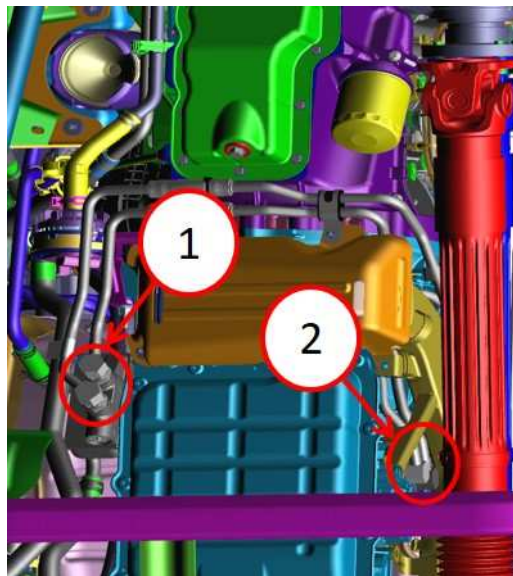
Fig. 1

Driver And Passenger Side Upper And Lower Quick Connects

- 1 - Passenger Side
2 - Driver Side
-

4. Visually inspect the passenger side transmission oil cooler line attachments to the transmission (Fig. 1) , both the upper and lower quick connects. The line ends should be engaged into the quick connects (Fig. 2) . If a quick connect is not engaged push the line fitting into the transmission quick connect until a 'click' is heard or felt.

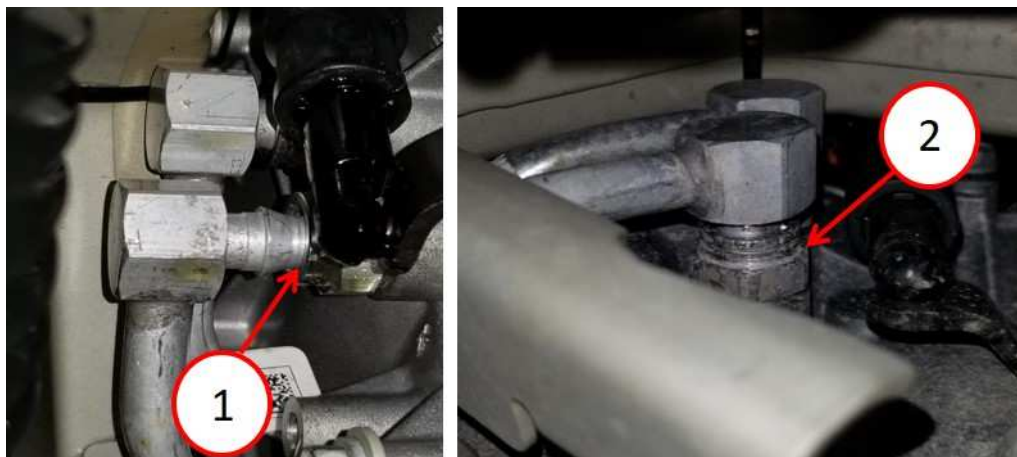
Fig. 2

Not Connected And Connected Quick Connects

- 1 - Not Fully Engaged Connected Quick Connects
 - 2 - Fully Engaged Connected Quick Connects
-

5. Perform a "push-pull-push" check on all the quick connectors performing the following steps:
 - a. Push the connections into the transmission, then push up, down, left and right.

- b. Pull the connections outward from the transmission, then pull up, down, left and right.
 - c. Push the connections again into the transmission.
6. Lower the vehicle.
