NUMBER: 18-015-21 REV. A

GROUP: 18 - Vehicle Performance

DATE: August 12, 2021

Flash: Powertrain Control Module (PCM) Updates

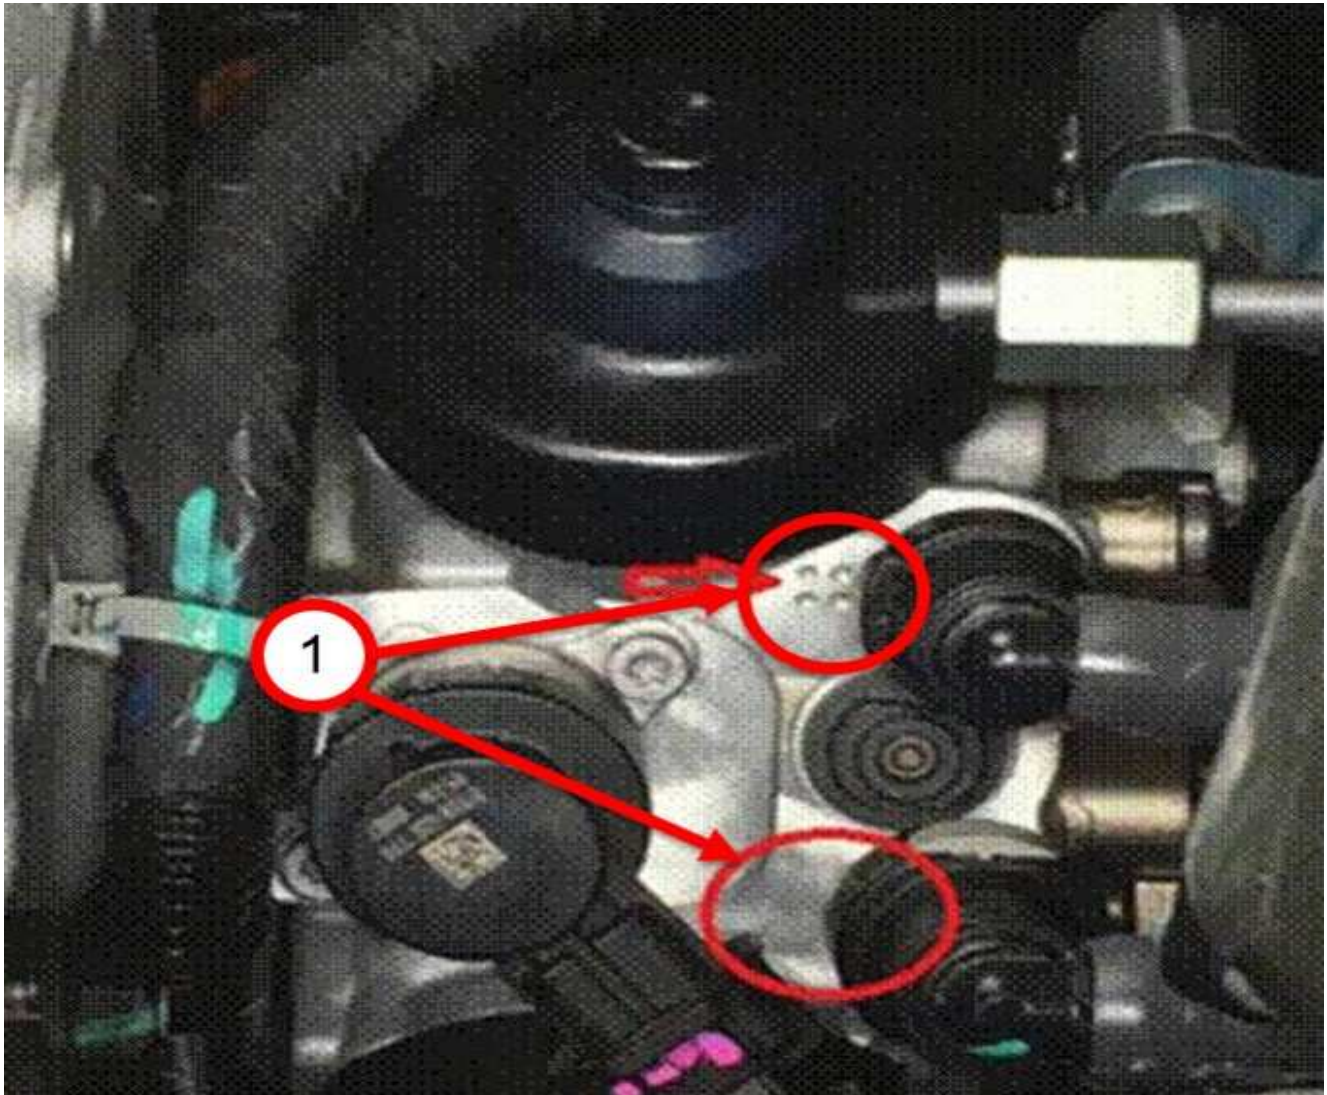
Fig. 2

Old Style Asymmetrical Cam Design Pump

1 - Multiple Small Dots or No Dots Embossed In The Pump Housing.

- Vehicles with the old style Asymmetrical Cam design will have multiple small dots or no dots embossed in the pump housing (Fig. 2) .
- For vehicles with an Asymmetrical Cam pump, choose the calibration labeled Asymmetric Cam or Asym Cam.
