Flash: Instrument Panel Cluster (IPC) Updates

This bulletin involves reprogramming the IPC with the latest available software.

2020 - 2021 (BV) Jeep Renegade

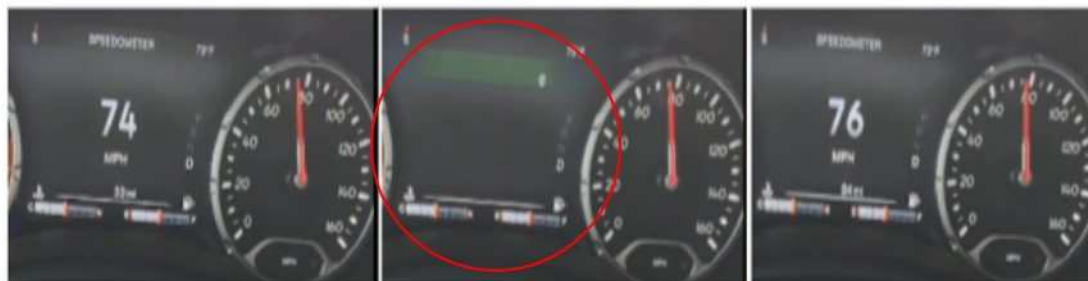
- The Electronic Vehicle Information Center (EVIC) screen goes blank and only displays a green bar at the top at 120 kph (75 mph) (Fig. 1) .

**Fig. 1**  
**Green Bar Appearing**

1. **\*\*Is the vehicle on the RRT VIN list?**
  - YES>>> Proceed to [Step 2](#).
  - NO>>> Proceed to [Step 3](#).
2. Does the IPC have the latest software installed?
  - YES>>> This bulletin has been completed, use inspect LOP (18-19-47-CM) to close the active RRT.
  - NO>>> Proceed to [Step 3](#).**\*\***
3. Reprogram the IPC with the latest software. Detailed instructions for flashing control modules using the wiTECH Diagnostic Application are available by selecting the application's "HELP" tab.
4. Disconnect the wiTECH pod.
5. Cycle the ignition 'off' and allow vehicle to go to sleep for two minutes.
6. Reconnect the wiTECH pod.
7. Clear all DTCs that may have been set in any module due to reprogramming. The wiTECH application will automatically present all DTCs after the flash and allow them to be cleared.
