NUMBER: 14-008-21

3.0L Diesel Crankshaft Tone Wheel Loss of Signal - X95 Warranty Extension

2014 - 2018 (WK) Jeep Grand Cherokee

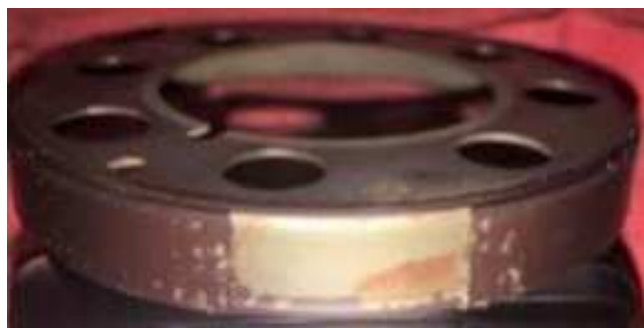
Customers may experience a Malfunction Indicator Lamp (MIL) illumination. Upon further investigation, a technician may find one or more of the following Diagnostic Trouble Codes (DTCs) have been set:

- P0335-00 - Crankshaft Position Sensor Circuit.
- P0336-00 - Crankshaft Position Sensor Performance.

- The vehicle will not accelerate quickly over 80 kph (50 mph) (vehicle is in limp mode).

NOTE: This symptom/condition is cause from missing magnetic material on the crankshaft tone wheel (Fig. 1) .

Fig. 1
Missing Magnetic Material On Tone Wheel

This bulletin involves replacing the crankshaft tone wheel.

If the customer describes the symptom/condition listed above or if the technician finds the DTC, perform the Repair Procedure.
