**NUMBER:** 14-007-21

3.0L Diesel Crankshaft Tone Wheel Loss of Signal - X94 Warranty Extension

This bulletin involves replacing the crankshaft tone wheel.

2014 - 2018 (DS) RAM 1500 Pickup

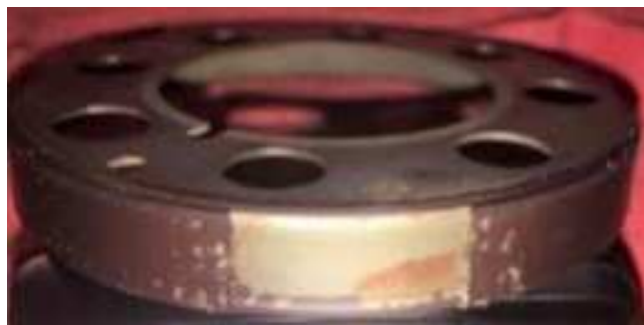
**NOTE:** This symptom/condition is caused from missing magnetic material on the crankshaft tone wheel (Fig. 1) .

**Fig. 1**  
**Missing Magnetic Material On Tone Wheel**
