**NUMBER:** 08-138-21

**GROUP:** 08 - Electrical

UAV and UCV Radio Enhancements

This bulletin involves inspecting and if required, updating the radio software level to: 39.6.

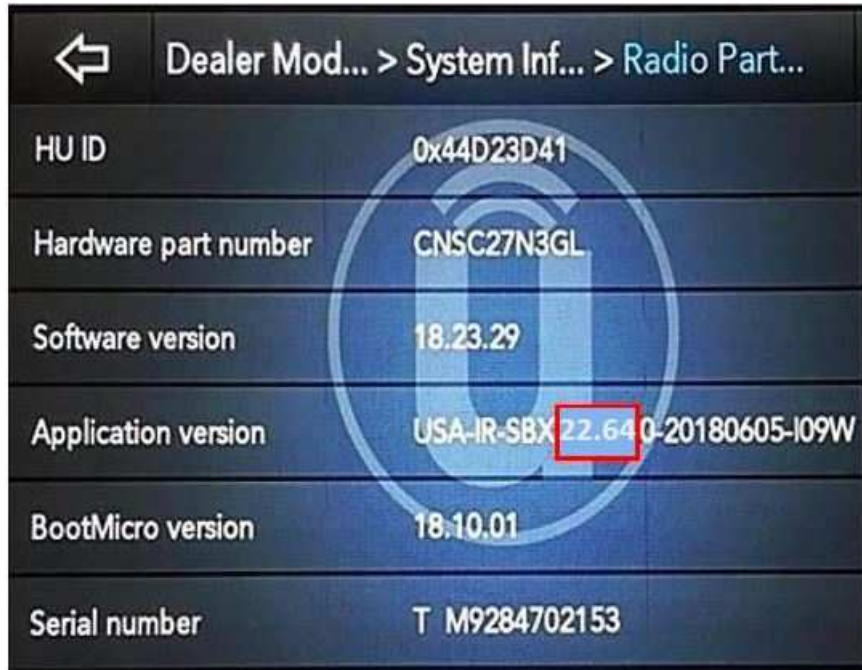
Fig. 1  
Radio Software Level Screen

1. Verify the radio software version. Radio must be in Dealer Mode to verify by following these steps:
  - a. Press and hold both lower corners of the display screen, until the Dealer Mode screen appears (approximately seven seconds). Release screen.
  - b. Select "Radio Part Information". The software version will be listed next to "Application Version" (Fig. 1) .

2. What is the radio software level (Application Version) at?
  - 39.6 or higher >>> The radio software is already up to date. Normal diagnostics should be performed.
  - At or above 22.64 and under 39.6 >>> Proceed to [Step 1](#) of the Repair Procedure.

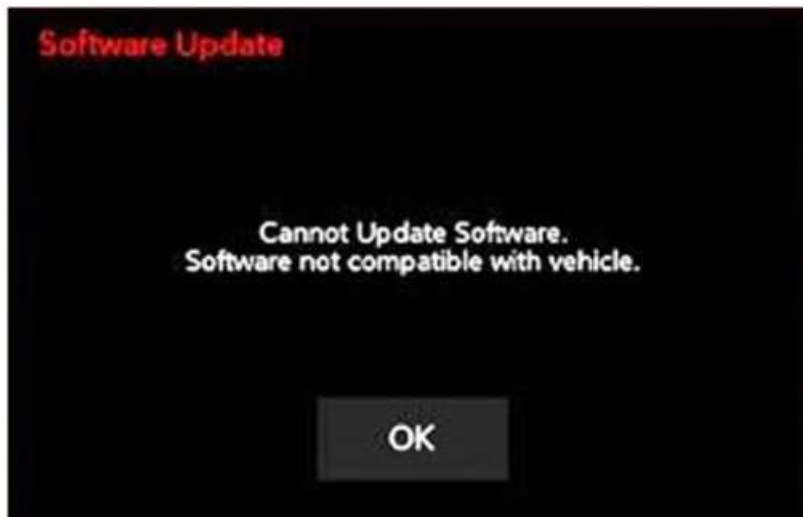
Fig. 5  
Software Not Compatible Screen

- If the screen in (Fig. 5) is displayed, the USB flash drive was not set up correctly. Use a top name brand USB flash drive, like Kingston, create a new USB flash drive and start the update again.
