STAR ONLINE PUBLICATION

Case Number: S2108000192

Symptom/Vehicle Issue: MIL Lamp On, Vehicles Engine Runs Rough, Poor Performance

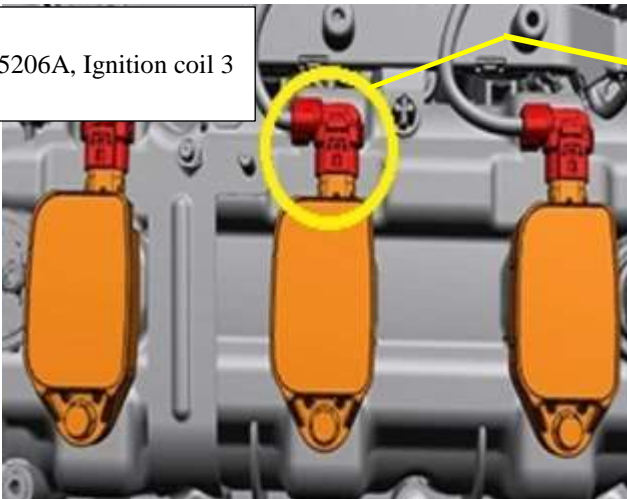
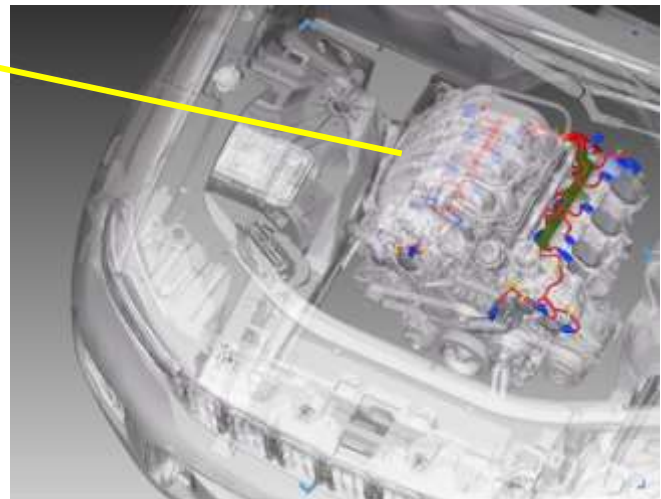
D5206A, Ignition coil 3

Customer Complaint/Technician Observation: Owner complains the MIL (Malfunction Indicator Lamp) is on. Technician observed the vehicle is setting DTC P0353 Ignition Coil Three Primary Circuit as stored or active.

PCM P0353 Stored - Ignition Coil 3 Circuit

Repair Procedure: Inspect the number 3 coil connector location as highlighted, secure the connector at the coil using the push, pull, push method. No parts required.
