STAR ONLINE PUBLICATION

Case Number: S2108000194

Release Date: August 2021

Symptom/Vehicle Issue: High Beams Do Not Turn On While The Headlamp Switch Is Set To The Auto Lights On Position, High Beam Headlamps Do Operate With Switch Set To Manual Lights On Low Beam Position

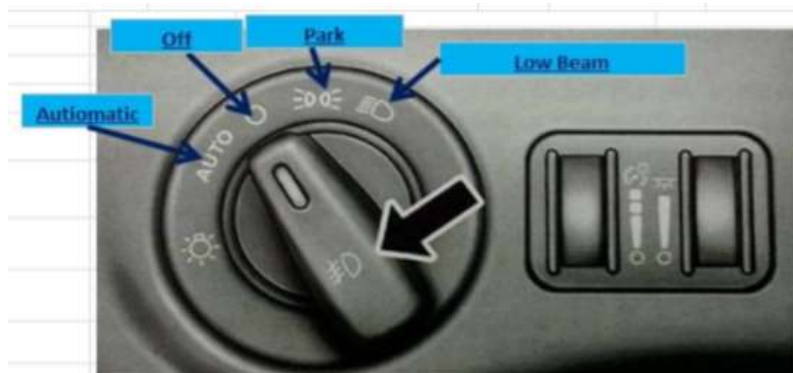
Customer Complaint/Technician Observation: Owner would like the high beam functionality to be available in both auto head lamp on position and manual head lamp on low beam position. Technician has validated the high beams do work as described above, but not at the owners desired position.

Discussion: No repairs should be attempted, engineering is currently investigating the operation of the high beams to be featured in multiple head lamp switch settings. The field will be notified with any updates to improve.
