Case Number: S2123000065

Release Date: August 2021

Symptom/Vehicle Issue: Water Leaking From A Pillar Area

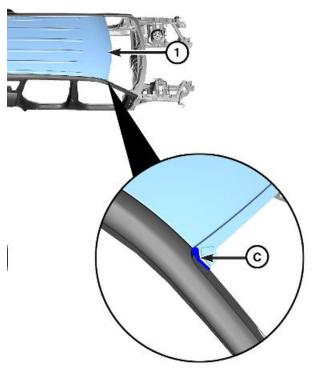
Fig 1 Upper corner of windshield.

Item C indicates factory applied sealer where additional seam sealer will needed if testing shows a leak path (bubble test)
