## STAR ONLINE PUBLICATION

**Case Number:** S2108000199

**Symptom/Vehicle Issue:** Check Engine Light (CEL), Start Stop Disabled, Vehicle Goes Into Limp In Mode

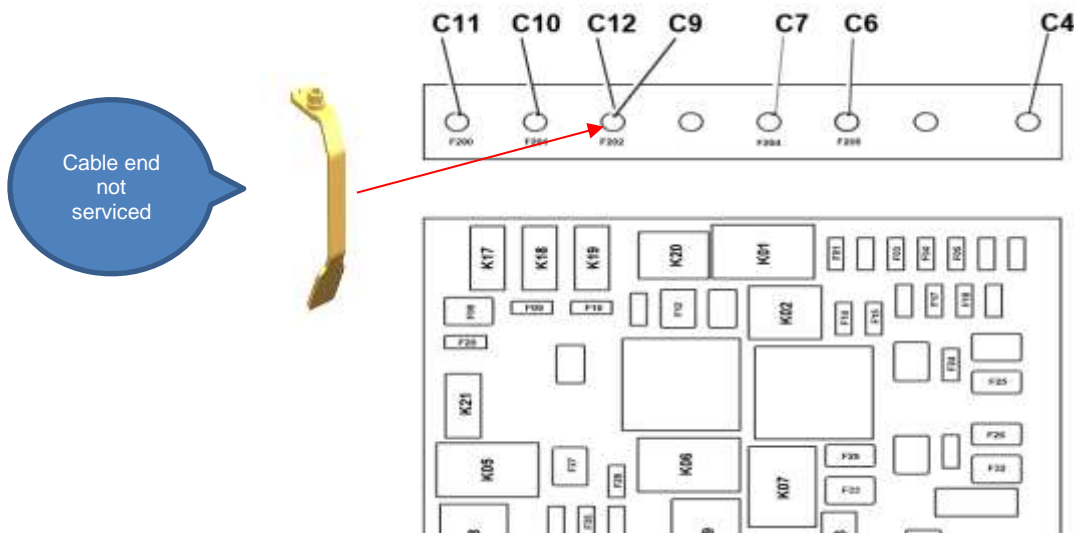
**Customer Complaint/Technician Observation:** Owner complains check engine warning lamp is on, start stop does not operate and or the vehicle goes into a reduced power limp mode. Technician observed the vehicle setting P0E33 DC/DC CONVERTER VOLTAGE SENSOR 1 LOW and or P1A20-00 BATTERY ENERGY CONTROL MODULE HYBRID BATTERY SYSTEM PRECHARGE TIME TOO LONG

**Repair Procedure:** Inspect the battery cable connection, F202 - 300amp fuse at the fuse array location to ensure it is secure; tighten as needed.

If the attachment nut and cable are secure, examine the cable to terminal end connection for any looseness peeling or separation that may be visible. Perform a voltage drop to ensure good connectivity of the welded terminal end to cable, cable ends are sonic welded connections and should not be serviced, order cable assembly as needed.
