STAR ONLINE PUBLICATION

Case Number: S2108000062 REV. A

Symptom/Vehicle Issue: Rumbling, Rough Engine Vibration 1600 to 1800, CEL (Check Engine Lamp) On, Cylinder Misfire DTC's

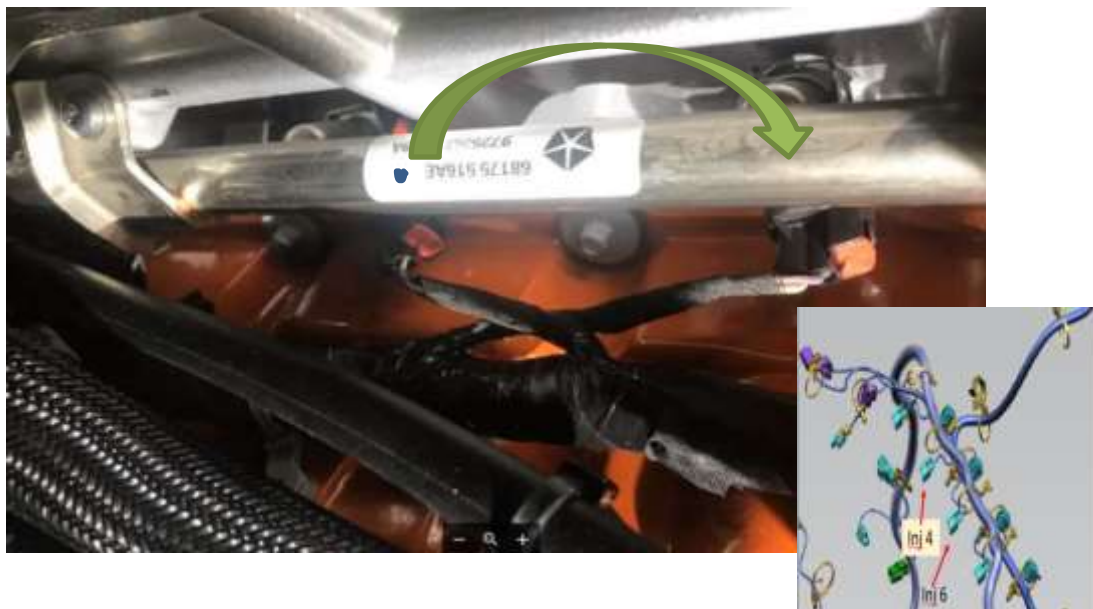
6.2L – DT Ram

Repair Procedure: The below example is consistent with the DTC's in this case, where the number 4 and 6 harness connections were improperly connected, (crossed) to the wrong injector position. Different DTC's will set if other injectors are involved. This condition may not set immediately but requires some driving and PCM fuel adaptive changing to trigger the DTC.
