STAR ONLINE PUBLICATION

Case Number: S2008000131 - Rev. C

Symptom/Vehicle Issue: U11E9 Lost Communication With AGS (Active Grille Shutter), Malfunction Indicator Lamp (MIL) Illuminated

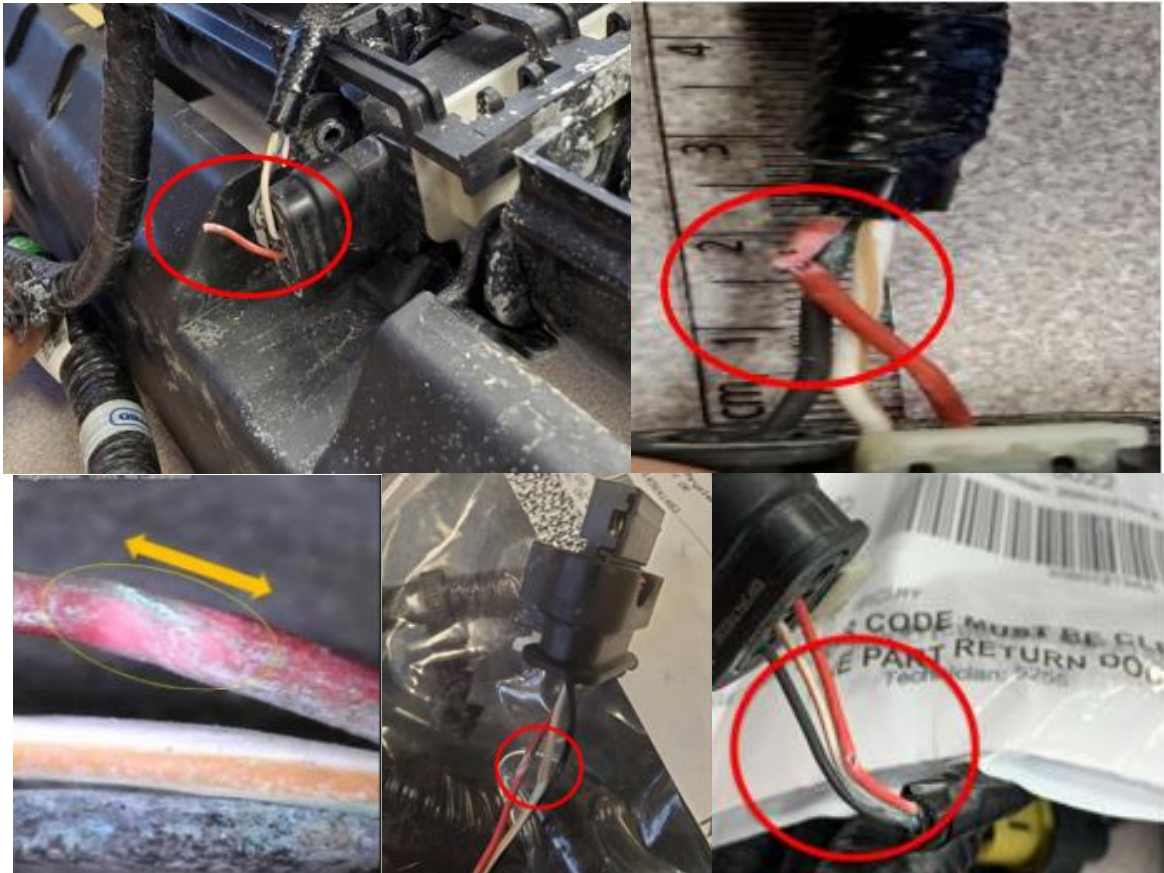
Discussion: Damaged fascia wiring harnesses are causing a loss of communication with fully functioning Active Grill Shutter(AGS) units.

Damaged AGS Wiring Harness Near D2826A

Repair: Use wiring kit 68396618AB to repair the fascia wiring harness or replace the harness if standard repair methods cannot be applied.
