STAR ONLINE PUBLICATION

Case Number: S2108000200

Symptom/Vehicle Issue: Buzz Or Rattle From Subwoofer Area Of Vehicle

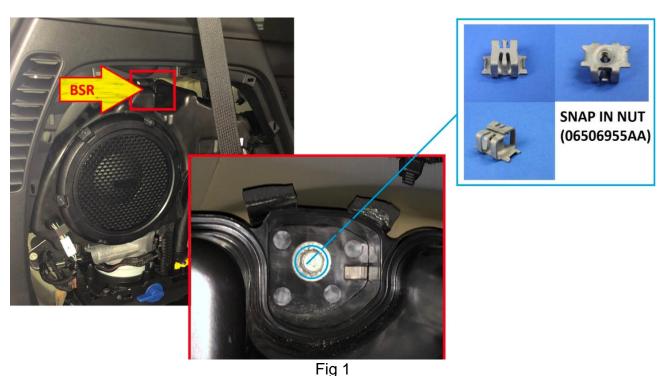
Discussion: Customer may hear a rattle or buzz (BSR) sound from rear of the vehicle from subwoofer area. This can occur at low audio volume levels. Inspect subwoofer fasteners and snap in nuts for movement between nut and body sheet metal. (Fig 1)

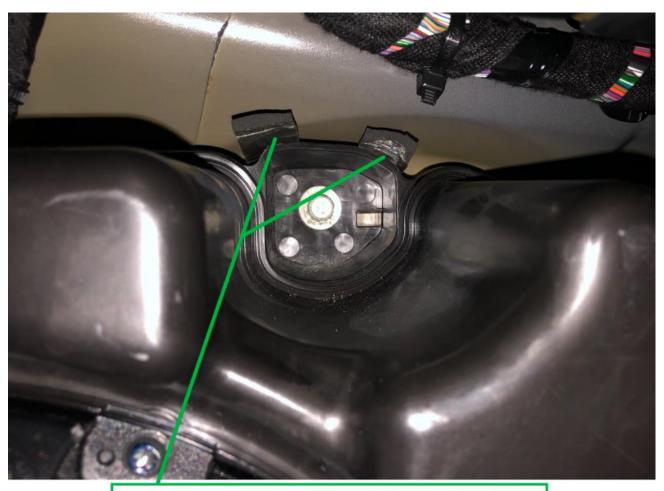
Fig 2

FOAM TAPE INSTALLED TO ELIMINATE BSR

Install foam tape as needed to eliminate movement between the snap in nut(s) and the body sheet metal. (Fig 2)
