STAR ONLINE PUBLICATION

Case Number: S2108000032

Symptom/Vehicle Issue: The Digital Speedometer Changes To A Green Bar At 75 MPH. The Analog Speedometer Continues To Function

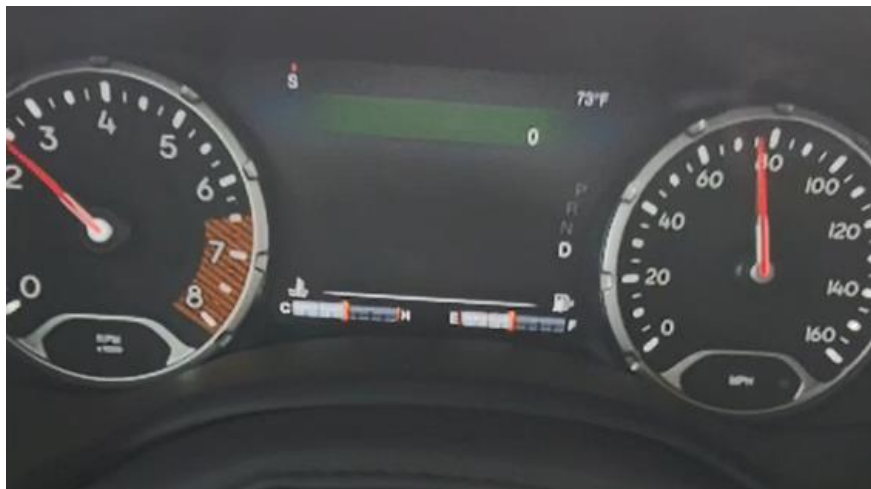
Discussion: The digital EVIC speedometer may change to a green bar as the vehicle speed changes from 74 MPH to 75 MPH. The analog speedometer will continue displaying the correct vehicle speed.

Diagnosis: Test drive the vehicle and slowly accelerate from 74 MPH to 75 MPH. If the speedometer reading changes to a green bar as shown below, this STAR Online applies.

Repair: Engineering is currently developing an IPC software update to address this issue. With an anticipated release date early 2nd quarter, 2021.

Cluster replacement WILL NOT Resolve this concern.
