## STAR ONLINE PUBLICATION

**Case Number: S1808000233 – Rev. A**

**Symptom/Vehicle Issue:** The Passive Entry Door Handle Does Not Unlock The Door And B25A3-00 Or B25A4-00 May Be Active

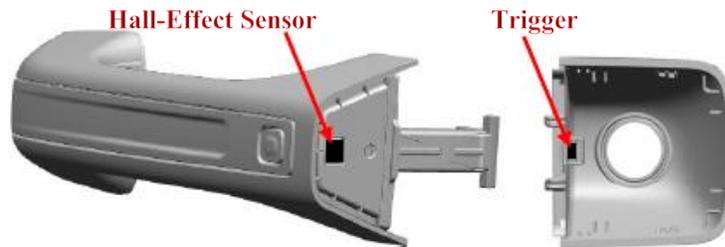
The Hall-Effect sensor is located at the rear of the door handle and interfaces with the Trigger located inside the door handle cap (lock cylinder cover).

Hall-effect Switch  
(between handle sections)

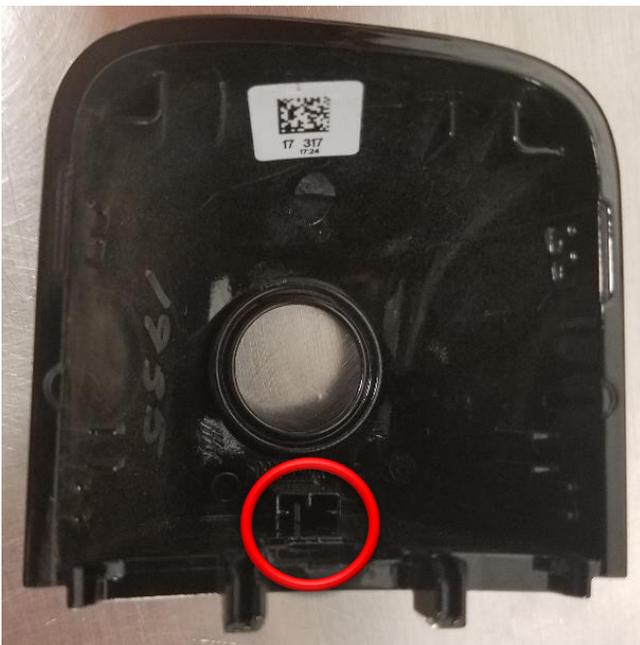
It has been determined that some vehicles came from the plant with the non-passive entry door handle caps installed or a door handle cap that was missing the Hall-Effect Trigger. A missing Hall-Effect Trigger will cause the system to believe the door handle is “Pulled” at all times.

**Hall-Effect Trigger Missing**

**Repair Procedure:** If you determine the Hall-Effect Trigger is missing or the incorrect door handle cap was installed. Replace the door handle cap and verify the Trigger is located within the new part prior to installation.

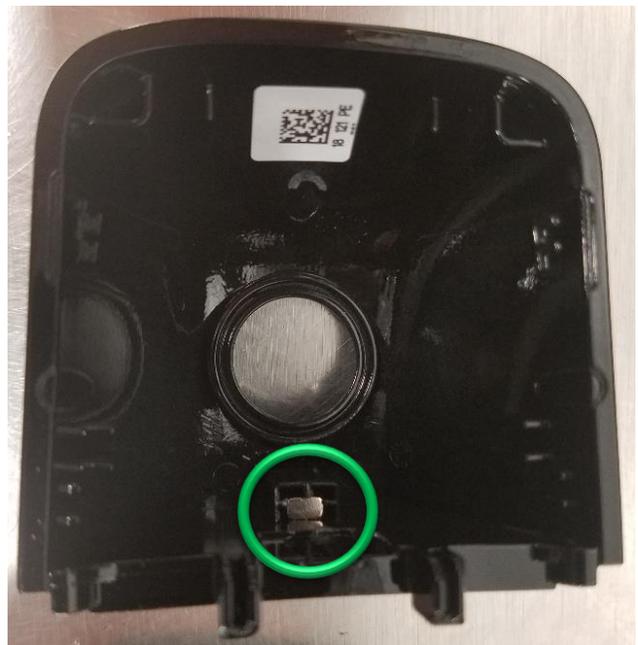
**Hall Effect Trigger Present**
