STAR ONLINE PUBLICATION

Case Number: S210800002 Rev. B

Symptom/Vehicle Issue: In Cold Temperatures The Customer May Complain Of An Intermittent No Crank, Cranks And Stalls, Stops Cranking Fails To Start

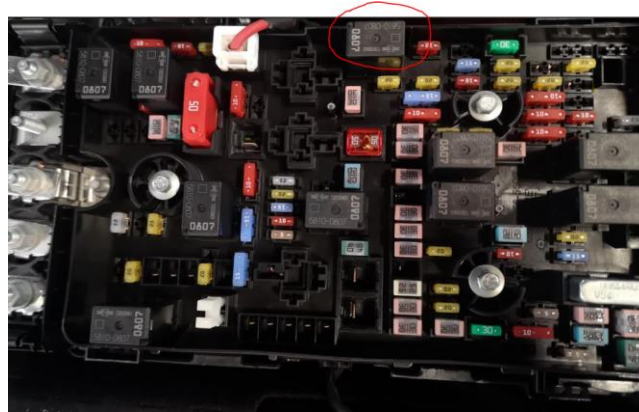
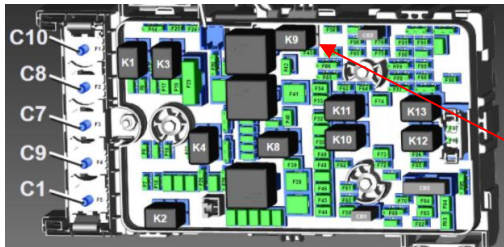
Repair Procedure: Inspect the Run/Start relay in the PDC and confirm it is manufactured by "Song Chuan" for vehicles built after September 2019. Replace the Song Chuan relay with the service replacement part (Denso 68406797AA). In the event 68406797AA is on backorder, another validated Denso relay to use is 68244159AA. Quantities for this relay are limited, we kindly request to only order on an as needed basis until mid March 2021 so customer vehicles currently exhibiting this issue can be repaired.

Verification: Verify the vehicle starts and does not stall and no DTC's are setting when exposed to the cold. It is recommended to cold soak the vehicle along with the replacement Denso relay. Attempt to start the vehicle and confirm a no start/start stall condition. Replace the Song Chuan Run/Start relay with the cold soaked Denso replacement. Verify the vehicle starts. If the issue has been resolved, no further action is needed. If the condition persists, follow the published service procedures to further diagnose the issue.
