STAR ONLINE PUBLICATION

Case Number: S2108000049

Symptom/Vehicle Issue: Windshield Washer Fluid Pump Does Not Function. Interior Rear Dome, Vanity And Glove Box Lamps Do Not Illuminate

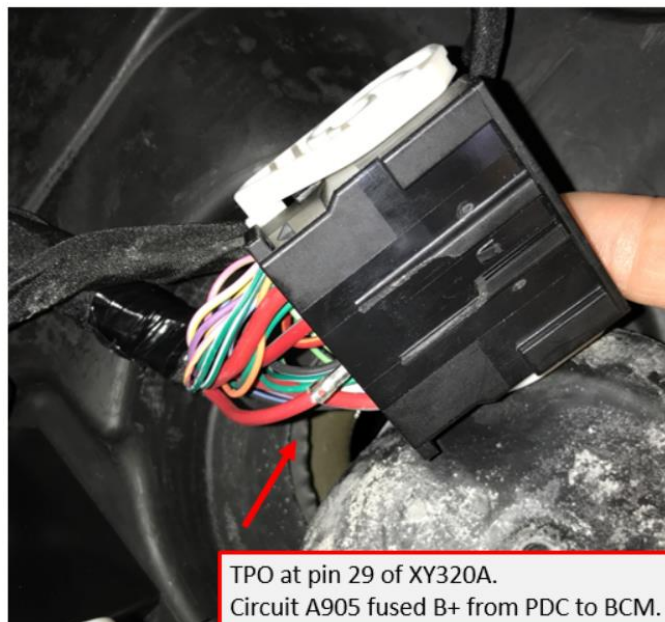
Diagnosis: Check for circuit issues with the fused B+ supply A905 through inline connector XY320A. Terminal Push Out concerns have been found at this connector. The A905 circuit supplies B+ voltage to the BCM which provides power the front washer fluid pump as well as the rear dome, vanity, and glove box lamps.

Do not immediately replace the BCM for this concern.
