STAR ONLINE PUBLICATION

Case Number: S2108000002 Rev. C

Symptom/Vehicle Issue: In Cold Temperatures The Customer May Complain Of An Intermittent No Crank, Cranks And Stalls, Stops Cranking Fails To Start

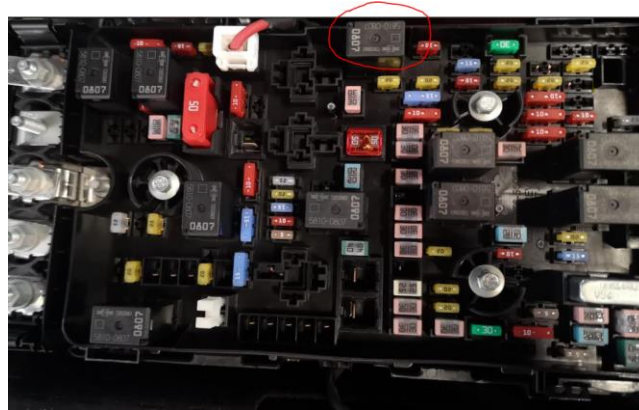
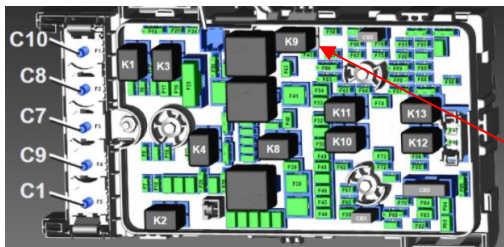
Customer Complaint/Technician Observation: Owner reports in colder temperatures the vehicle may exhibit a No Start or and/or a Start and Stall fail to Start condition. Vehicle will start normally when PDC or vehicle is warmed up. This symptom may also be accompanied by DTC P1279 - Starter Control Circuit 2 Open and/or P26E4 - Starter Control 2 Circuit.

Note: Only the Run/Start relay will require replacement for this issue. No other Song Chuan relays should be replaced for this condition.

Repair Procedure: Inspect the Run/Start relay in the PDC and confirm it is manufactured by "Song Chuan" for vehicles built after September 2019. Replace the Song Chuan relay with the service replacement part (Denso 68406797AA). In the event 68406797AA is on backorder, another validated Denso relay to use is 68244159AA. Quantities for this relay are limited, we kindly request to only order on an as needed basis until mid March 2021 so customer vehicles currently exhibiting this issue can be repaired.

CAUTION: Denso relay part number 68244159AA can only be used in the Run/Start relay location. Premature relay failure will occur if used in other locations. Other locations require relays which can handle higher duty cycle requirements.

Verification: Verify the vehicle starts and does not stall and no DTC's are setting when exposed to the cold. It is recommended to cold soak the vehicle along with the replacement Denso relay. Attempt to start the vehicle and confirm a no start/start stall condition. Replace the Song Chuan Run/Start relay with the cold soaked Denso replacement. Verify the vehicle starts. If the issue has been resolved, no further action is needed. If the condition persists, follow the published service procedures to further diagnose the issue.
