**NUMBER:** 18-011-21

Flash: Powertrain Control Module (PCM) Updates

2019	(DD)	RAM 3500 Cab Chassis
2019	(DP)	RAM 4500/5500 Cab Chassis

**NOTE: This bulletin applies to vehicles equipped with a 6.7L I6 Cummins Turbo Diesel Engine (Sales Code ETN).**

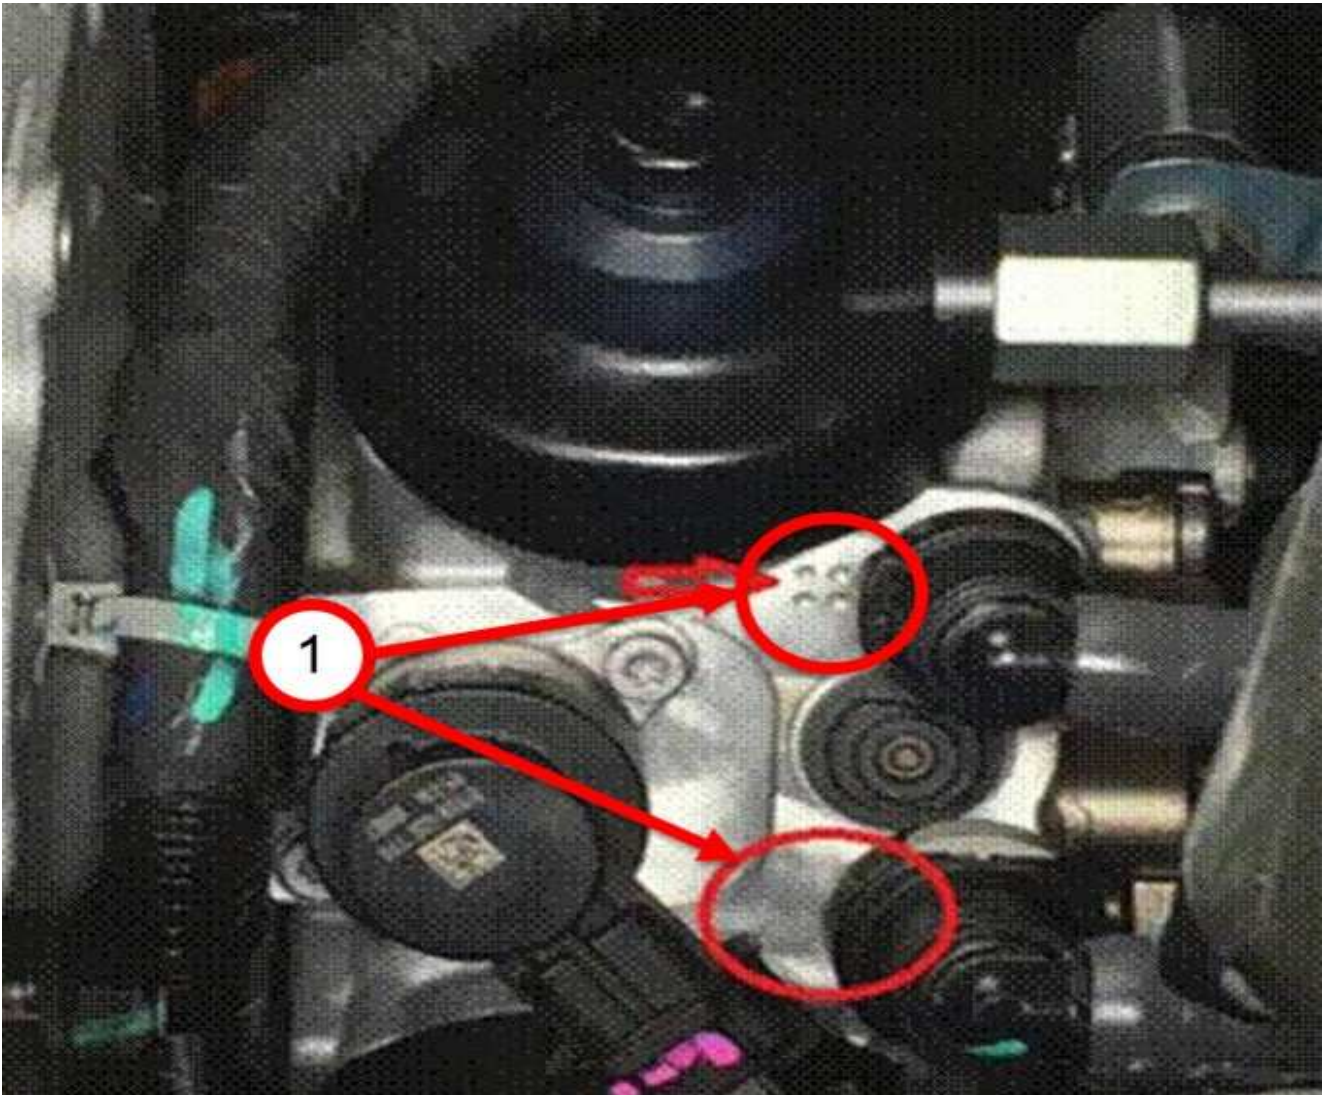
Fig. 2

- Vehicles with the old style Asymmetrical Cam design will have multiple dots embossed in the pump housing (Fig. 2) .
- For vehicles with an Asymmetrical Cam pump, choose the calibration labeled Asymmetric Cam or Asym Cam.

Old Style Asymmetrical Cam Design Pump

1 - Multiple Dots on Housing
