STAR ONLINE PUBLICATION

Case Number: S2121000002

Symptom/Vehicle Issue: Transmission Fluid Leak Inspection, Transmission Cooler Line Inspection

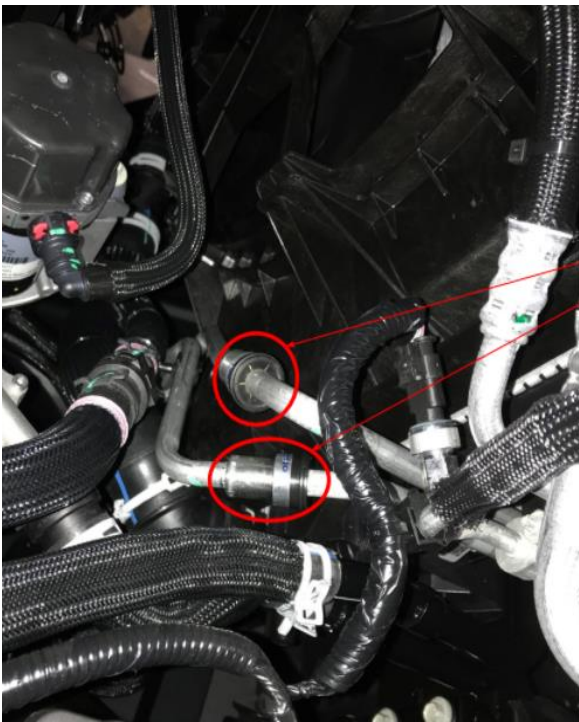
Locate TOC line connections to radiator at the front right side of the truck.

Perform a push/pull/push on both lines to verify they are fully seated.

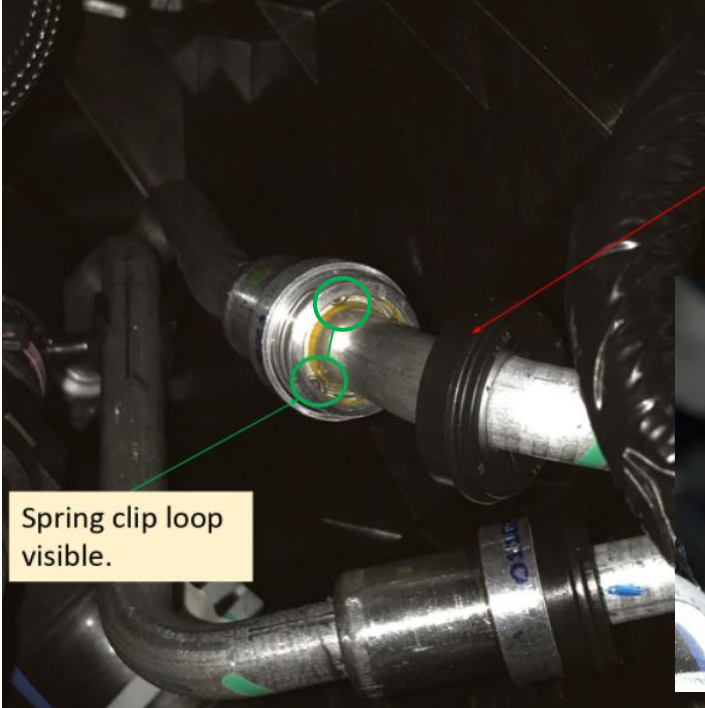
Pull back the black assurance cap and inspect the joint. Look for the line being fully seated as shown. Three spring clip loops should be visible .
