STAR ONLINE PUBLICATION

Case Number: S2108000064

Symptom/Vehicle Issue: Appearance Of A Coolant Leak On The Power Pack Unit (PPU) Fitting Due To Assembly Lubricant

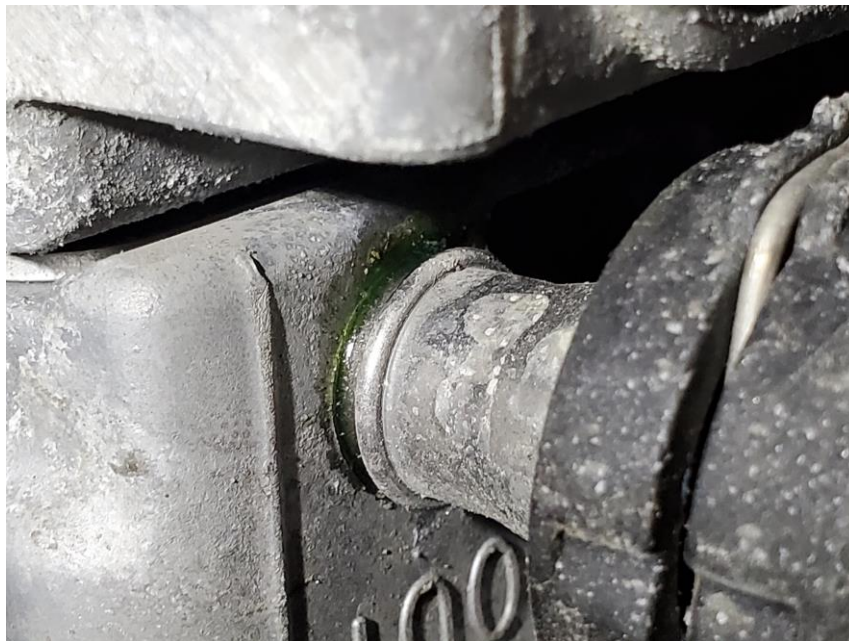
Discussion: Upon examining the PPU or underside of the vehicle, you may discover the appearance of a green discharge at the PPU coolant fitting. The green substance is often associated with Coolant, but is actually lubricant used in the assembly of the PPU. This is normal and does not indicate a leak. **The PPU or any of its associated coolant lines SHOULD NOT BE REPLACED for this condition.**

Green Assembly Lubricant On PPU Coolant Fitting
