## STAR ONLINE PUBLICATION

**Case Number: S2108000075**

Symptom/Vehicle Issue: Transfer Case Terrain Selector Switch LED Inoperative

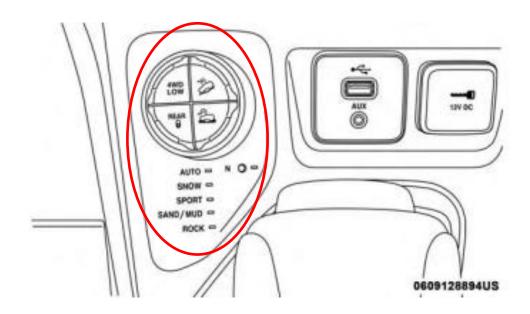
Fig 1

**Customer Complaint/Technician Observation:** Owner complains the Terrain switch does not illuminate and or change modes and the upper switch bank LEDS do not illuminate. Technician observed the vehicle is setting a BCM DTC, U1046-11 LIN 4 BUS Circuit.

**Repair Procedure**: Inspect the mirror jumper harness at the A pillar location. Inspect the harness fastener points for any signs of pinched and or damaged mirror jumper harness circuits. Repair and or replace the harness as needed Fig 1, 2.
