STAR ONLINE PUBLICATION

Case Number: S2108000076

Symptom/Vehicle Issue: CEL Check Engine Lamp On, DTC P00F9 Supercharger-Turbocharger Outlet Pressure Sensor Range Performance

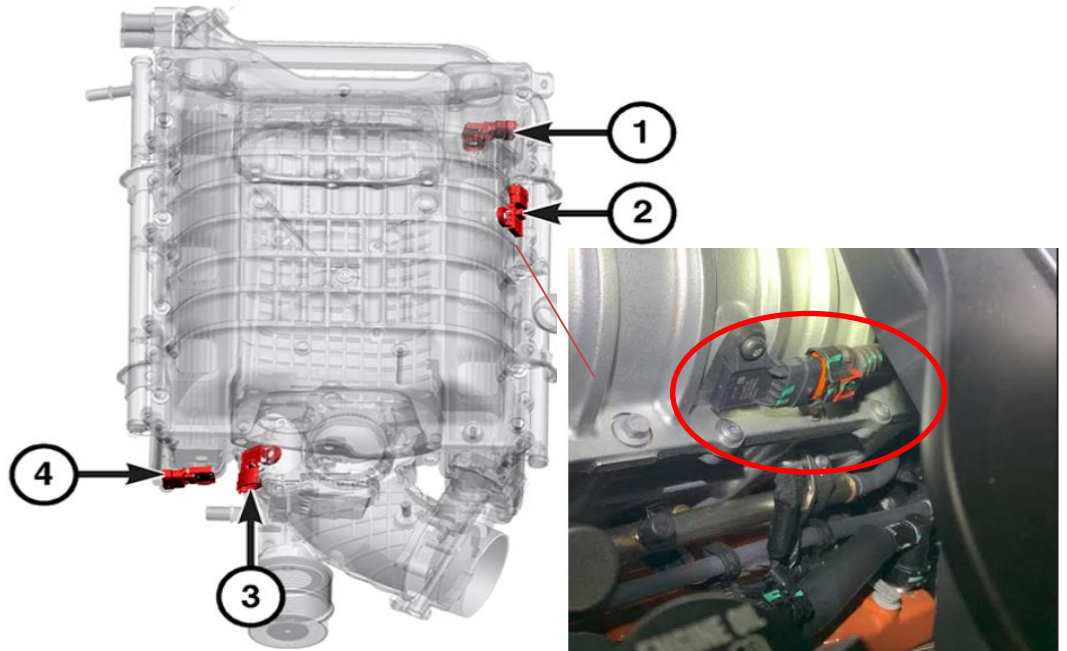
Intake TMAP Sensors

Customer Complaint/Technician Observation: Owner complains the CEL lamp is on. Technician observed PCM DTC P00F9 – Supercharger/Turbocharger Outlet Pressure Sensor Range Performance.

(1) Bank 1 TMAP Sensor	(3) Supercharger Inlet TMAP Sensor
(2) Supercharger Outlet TMAP Sensor	(4) Bank 2 TMAP Sensor
Inlet Air Temperature (IAT) not shown

Repair Procedure: Inspect the # 2 Outlet TMAP Sensor position and secure the connector as needed. Inspect others to complete, no parts required.
