NUMBER: 08-033-21

GROUP: 08 - Electrical

UGQ Radio Enhancements

2019 - ****2020**** (KL) Jeep Cherokee

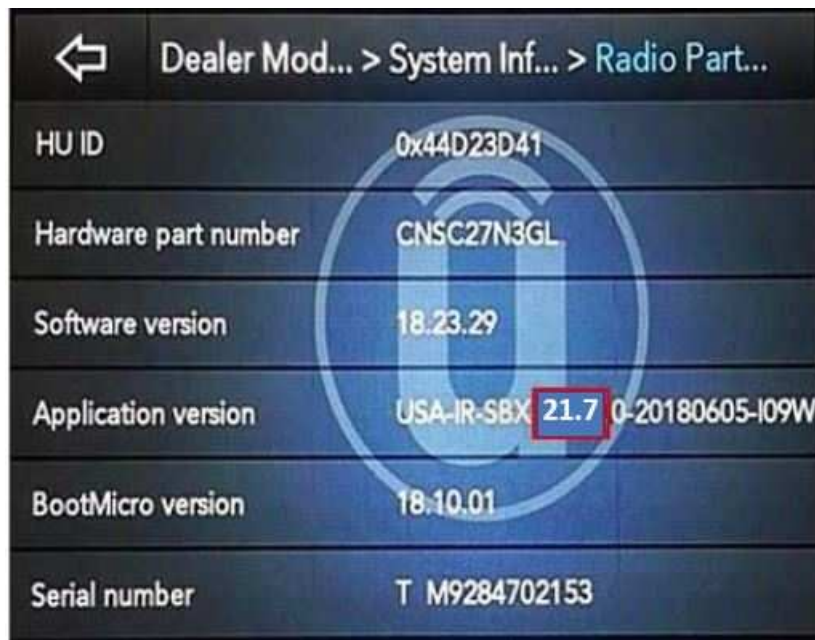
Fig. 1

1. Verify the radio software version. Radio must be in Dealer Mode to verify by following these steps:
 - a. Press and hold both lower corners of the display screen, until the Dealer Mode screen appears (approximately seven seconds). Release screen.
 - b. Select "Radio Part Information". The software version will be listed next to "Application Version" (Fig. 1) .

Radio Software Level Screen

2. What is the radio software level (Application Version) at?
 - 39.5 or higher >>> The radio software is already up to date. Normal diagnostics should be performed.
 - At or above 28.41 and under 39.5 >>> The radio will only **need one USB flash drive** to update the radio. Create a USB flash drive with 39.5 software. Proceed to [Step 1](#) of the Repair Procedure.

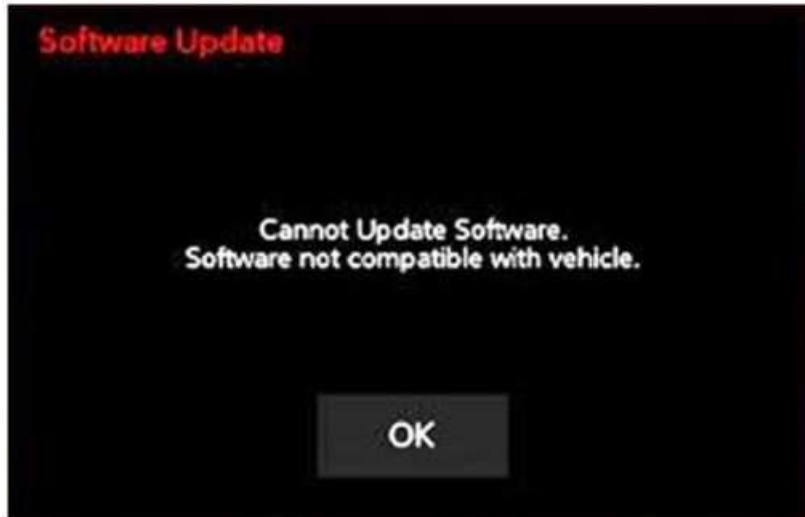
11. If the screen in (Fig. 5) is displayed, the USB flash drive was not set up correctly. Use a top name brand USB flash drive, like Kingston, create a new USB flash drive and start the update again.

Fig. 5
Software Not Compatible Screen

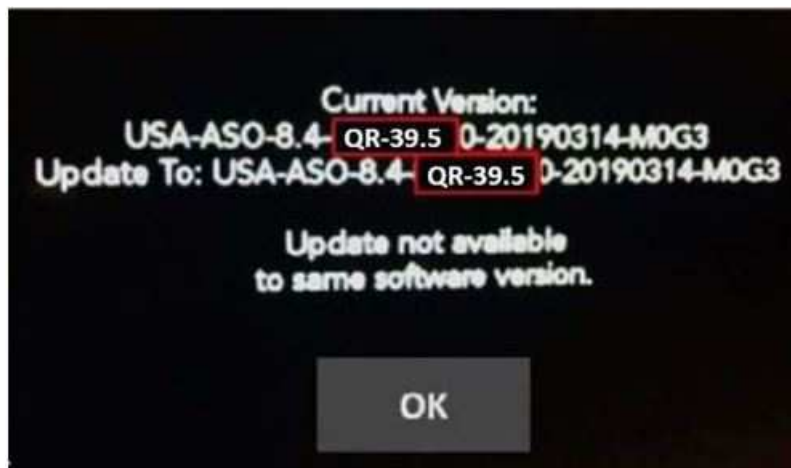
12. If the radio software is already up to date, the screen in (Fig. 6) will be displayed. Press "OK" and remove the USB flash drive.

Fig. 6
Screen Displayed When Radio Software Level Is Up To Date

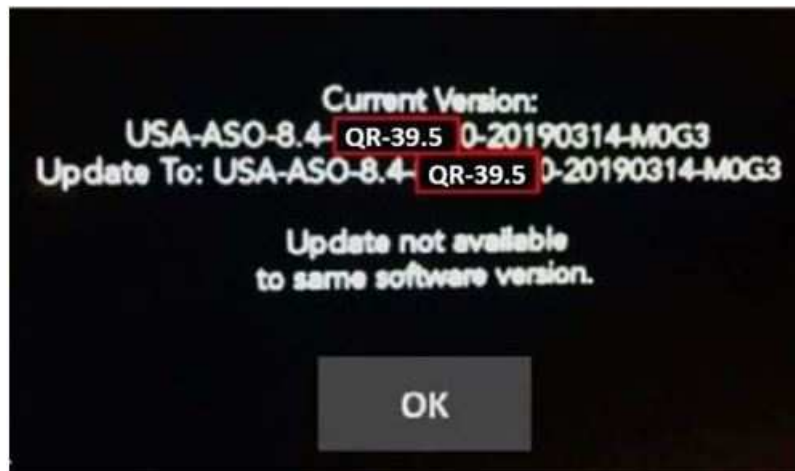
16. After the update has completed, the radio will shut down. With the USB flash drive still inserted in the USB port, cycle the ignition back to the run position. If the radio software was updated correctly the "Current Version:" and the "Update To:" software levels in (Fig. 10) will display the identical software level. Press "OK" and remove the USB flash drive.

Fig. 10
Radio Software Has Been Updated
