**NUMBER:** 08-051-21

UBN, UEN, UBG and UEG Radio Over The Air Software Version Updates

2021 (RU) Chrysler Pacifica

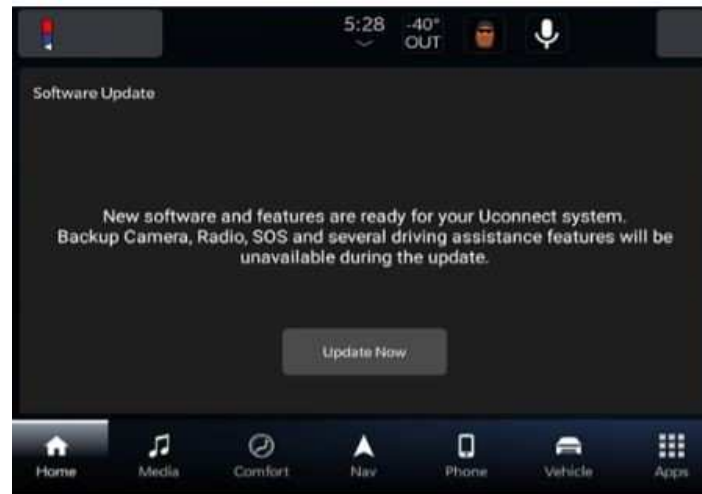
Fig. 1

### Software Acceptance Screen

1. The vehicle needs to be in 'park'. The ignition needs to be in the off position.
2. If the customer selects "Update Now" they can shut off the vehicle and leave. The update will be completed automatically.

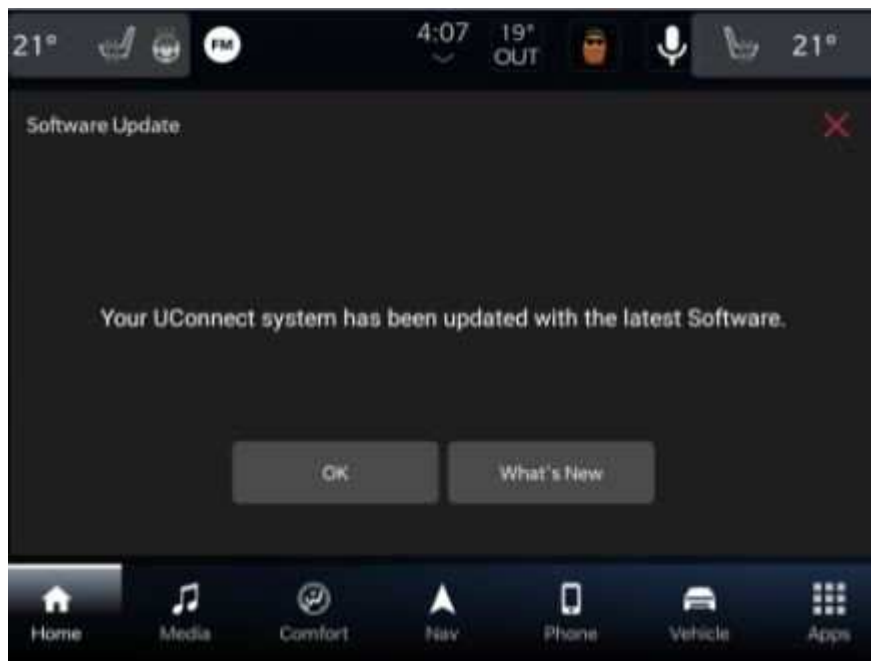
Fig. 2

3. Upon completion of update, the radio will display a confirmation message (Fig. 2) .

### Software Update Confirmation Screen
