**NUMBER:** 09-003-21 REV. A

**GROUP:** 09 - Engine

Transmission Oil Cooler Lines Not Fully Connected

**\*\*2021\*\*** (DT) RAM 1500 Pickup

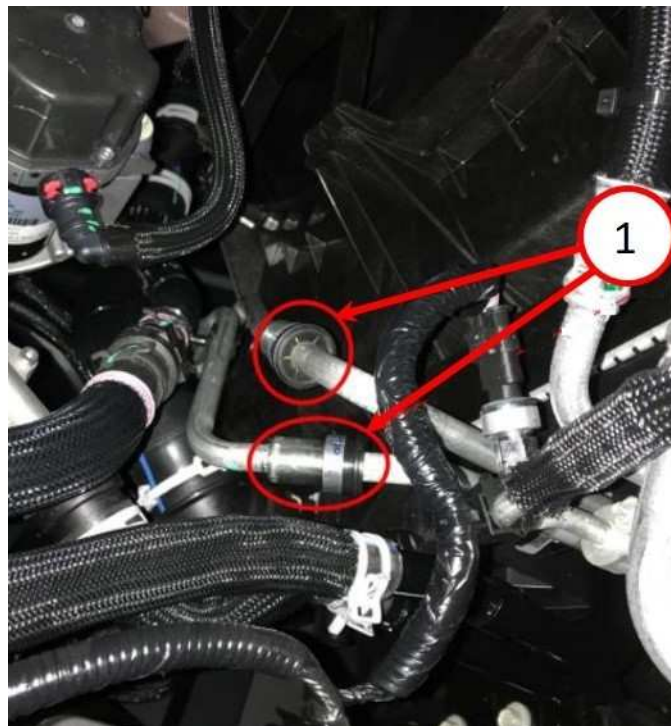
Fig. 1

1. Inspect the TOC lines by pulling on lines to see if they come loose and separate the connection. The black assurance caps (Fig. 1) need to be pulled back to inspect.

Transmission Oil Cooler Line (Shown Connected)

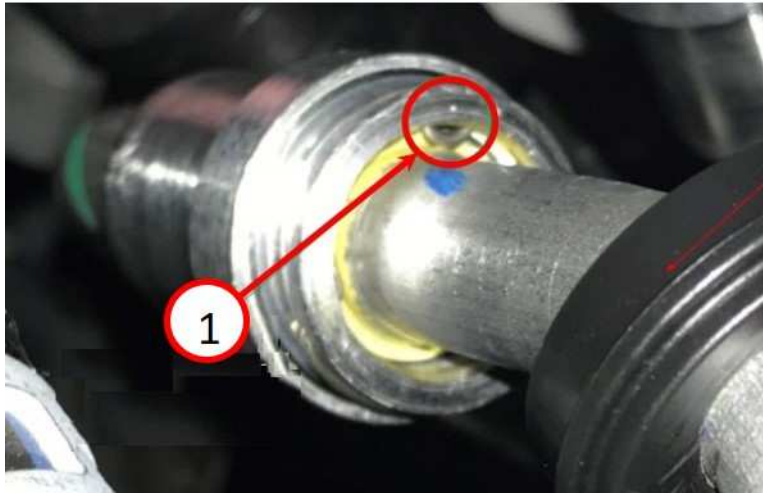
2. Look for the line to be fully seated. Three spring clip loops should be visible (Fig. 2) .

Fig. 2  
Spring Clip Loop (Shown With Assurance Caps Pulled Back)

1 - Spring Clip Loop

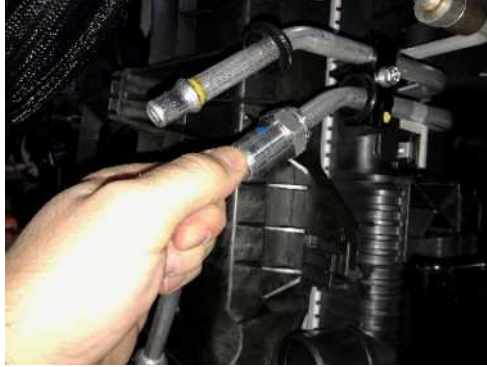
**Fig. 3****Transmission Oil Cooler Line (Connected)**

1. Align the TOC Line and slide into fitting .
2. Press on the tube until a 'click' is heard or felt.

**NOTE: The yellow paint bead will disappear into the fitting when tube is properly installed into quick connect (Fig. 3) .**

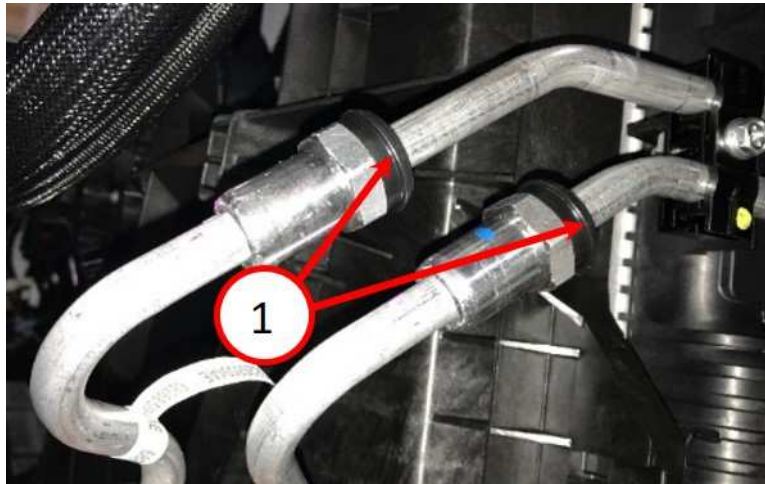
**Fig. 4****Assurance Cap (In Place)**

1 - Assurance Cap

3. Slide the assurance caps down the tube and snap the cap over the fitting. Listen or feel for a "snap" or "click" as the cap engages with the fitting (Fig. 4) .
