NUMBER: 03-001-21

Outer Halfshaft Axle Boots Leaking Grease

2021 (DT) RAM 1500 Pickup

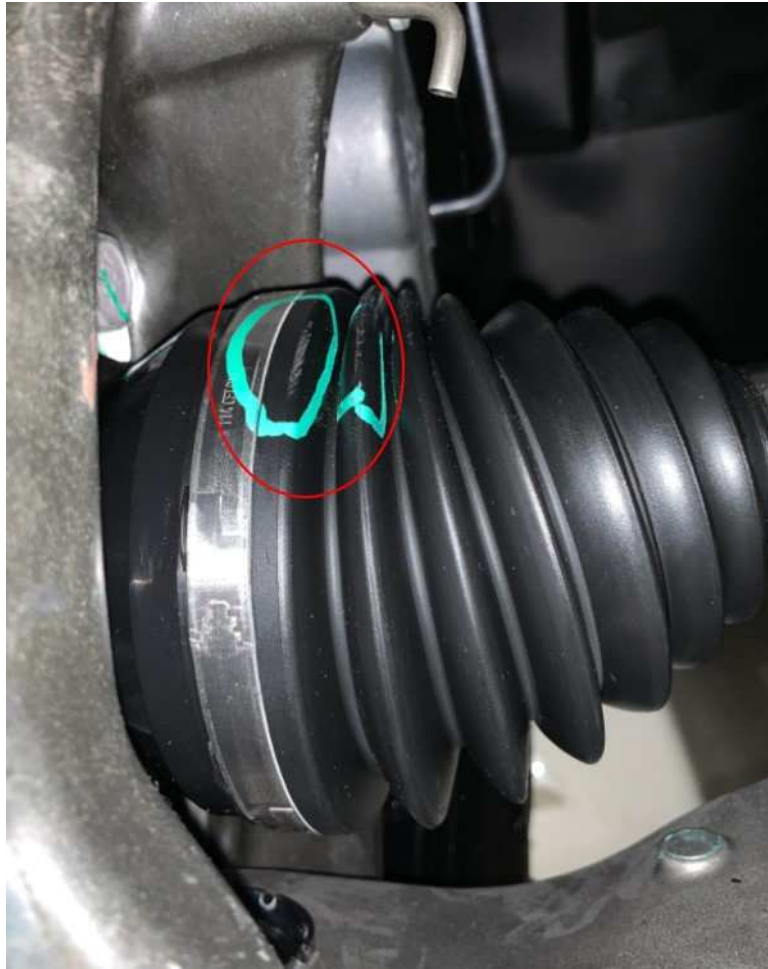
1. Raise the vehicle on a hoist and inspect both the driver's and passenger's sides outer halfshaft axle boots, rotate the halfshaft while looking for any type of abnormality (scuff or tear) (Fig. 1) ,(Fig. 2) ,(Fig. 3) , (Fig. 4) or (Fig. 5) . If either a scuff, indent or tear is found proceed to Step 2.

Fig. 1
Abrasion, Scuff

1. Replace the affected halfshaft axle(s). Refer to the detailed service procedures available in DealerCONNECT> Service Library under: Service Info> 03 - Differential and Driveline / Halfshaft / Removal and Installation.

NOTE: Only the halfshaft axle showing signs of tears, scuffs or abnormalities (Fig. 1) ,(Fig. 2) ,(Fig. 3) ,(Fig. 4) or (Fig. 5) should be replace not all vehicles will need both halfshafts replaced for this issue.

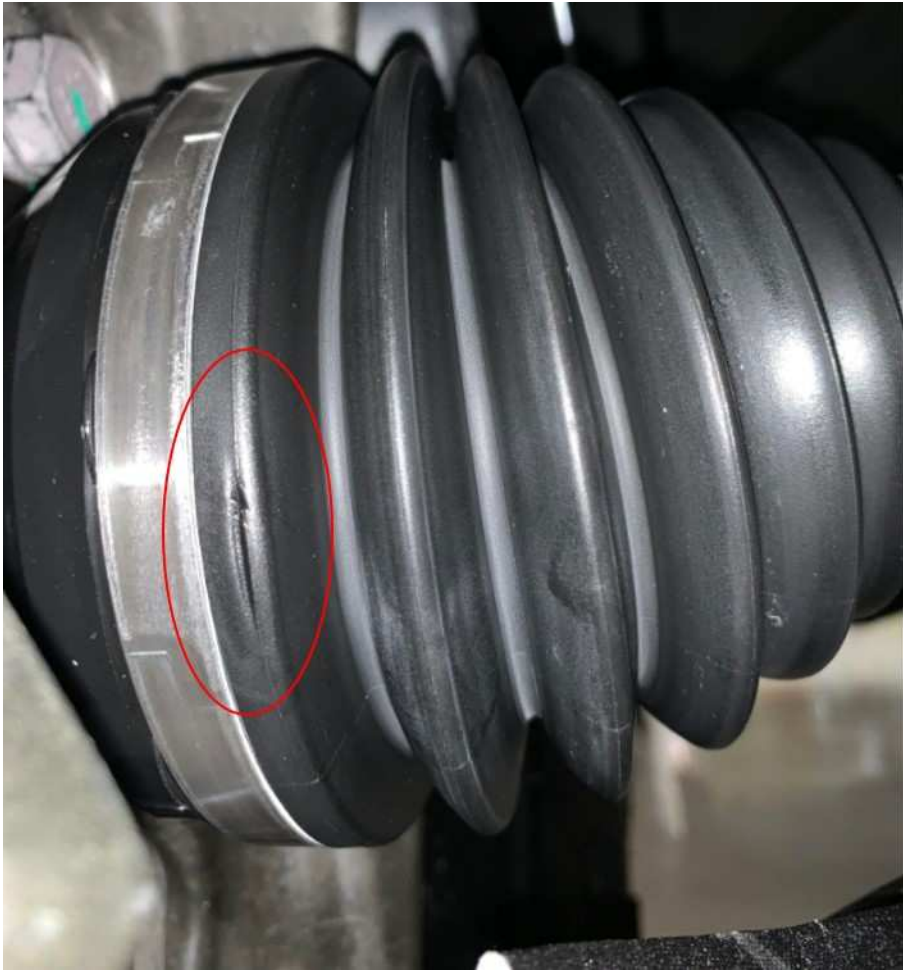
Fig. 2
Indentation

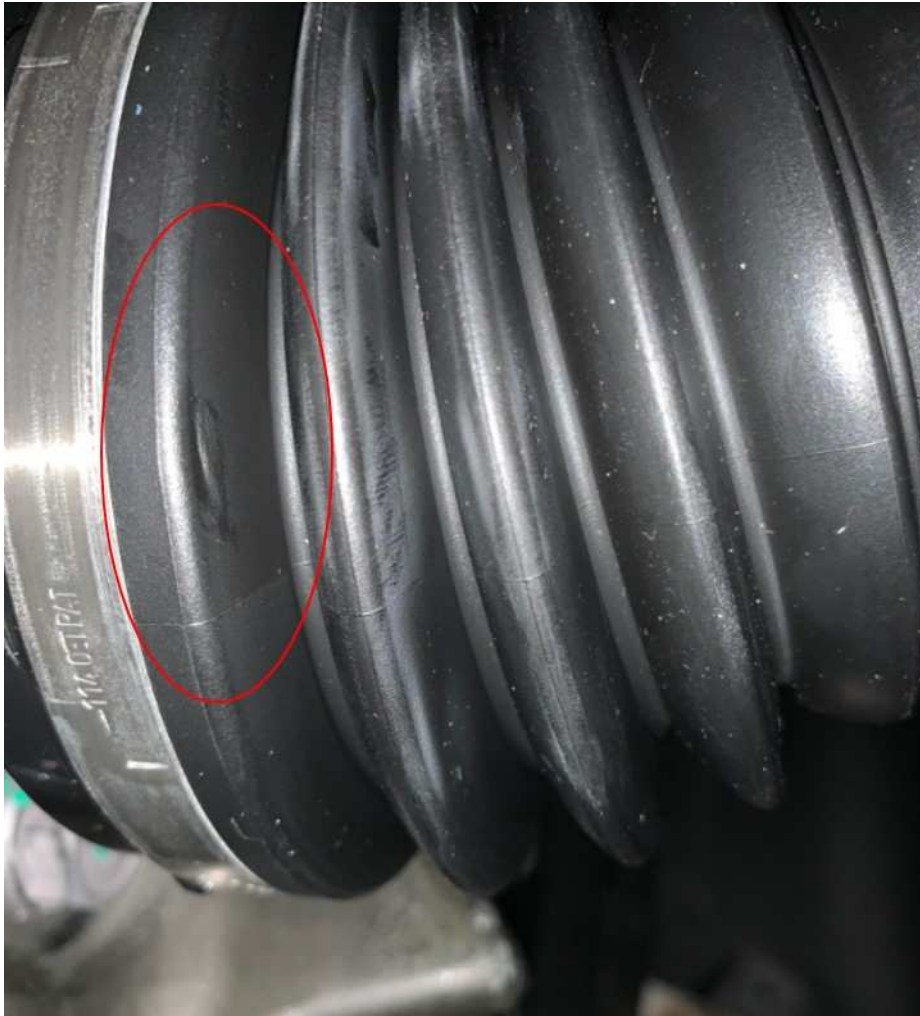
Fig. 3
Indentation Mark

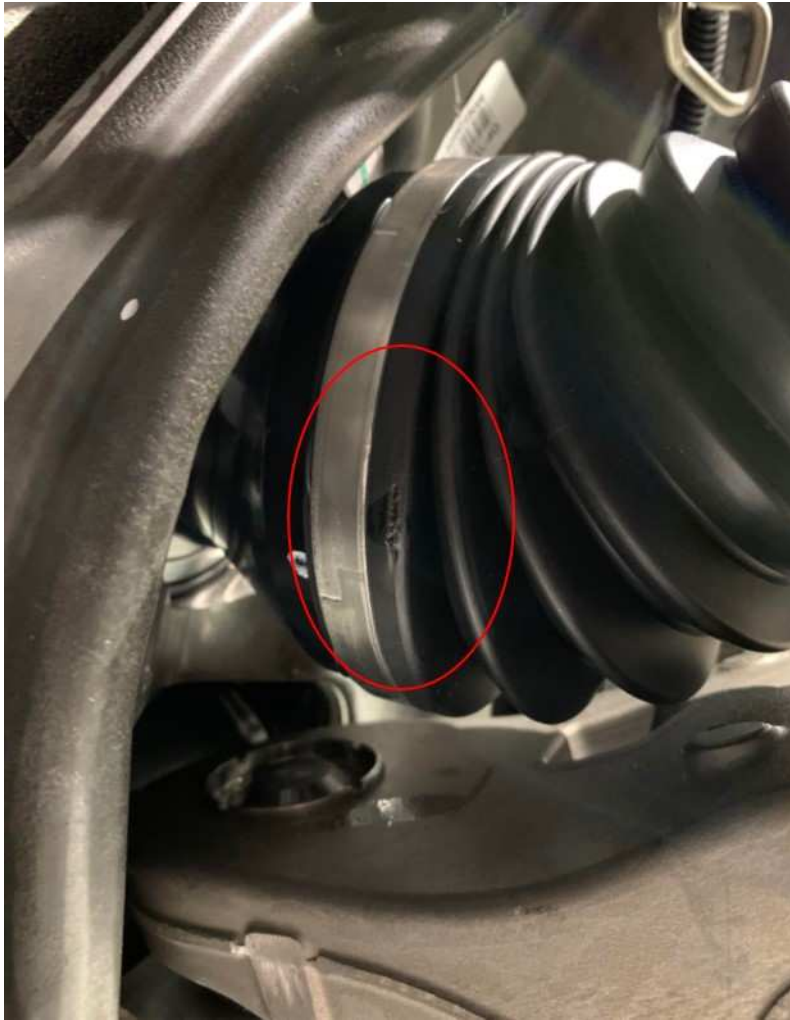
Fig. 4
Boot Tear/Cut

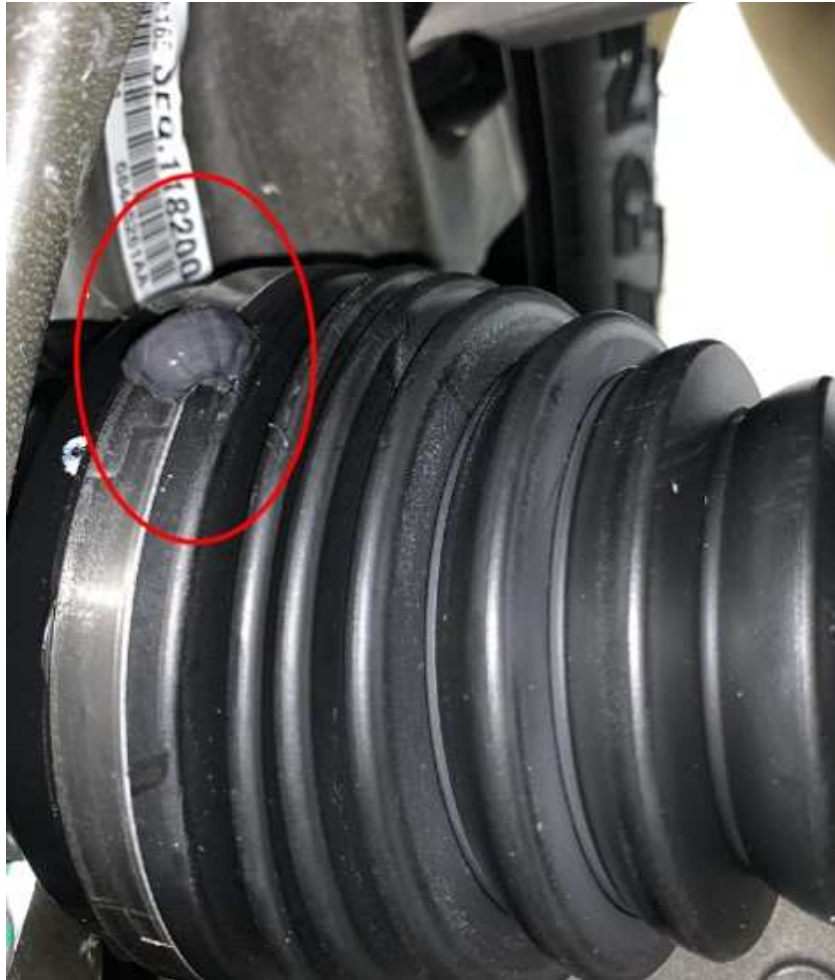
The customer or technician may experience a axle grease leaking out of one or both of the outer halfshaft axle boots, this can happen within 804 Km (500 miles).

Fig. 5
Boot Grease Leak
