## STAR ONLINE PUBLICATION

**Case Number: S2121000006**

**Symptom/Vehicle Issue:** Transmission Will Not Engage Into Gear

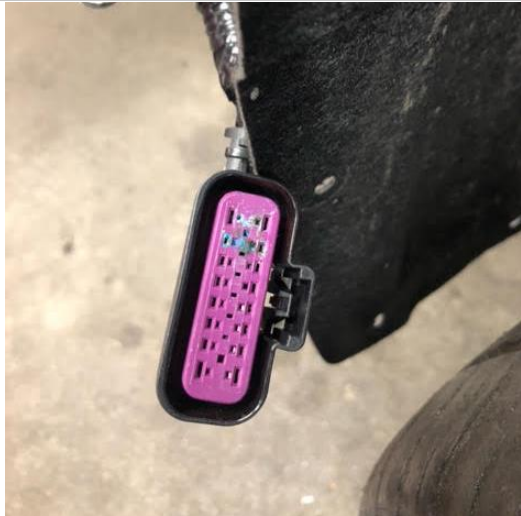
Figure 1

If you receive a vehicle with the above condition, inspect for corrosion in the XY105 connector and repair as necessary. Please see ([Figure 1 & 2](#)).
