STAR ONLINE PUBLICATION

Case Number: S2108000104

Symptom/Vehicle Issue: No Start, On Stop Start Vehicles A MIL Lamp On With DTC P0A97 Combined With The No Start

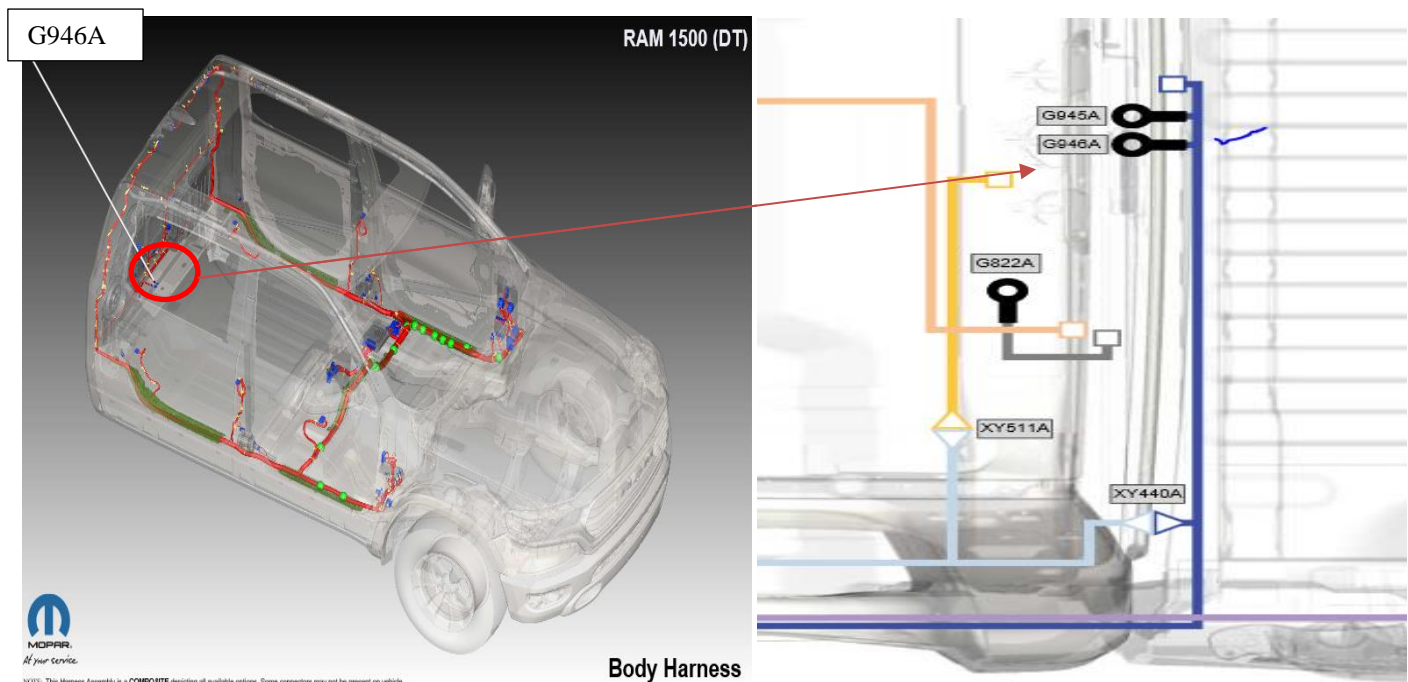
Customer Complaint/Technician Observation: Owner complains that the vehicle is not starting. Technician observes RFHUB response issues and on vehicles with BSG (Belt Start Generator) system, no start combined with DTC P0A97-00-HYBRID/EV COOLING FAN 2 PERFORMANCE/STUCK OFF.

Repair Procedure: Inspect the G946A ground location, clean and secure the ground location as needed no parts required.
