**NUMBER:** 18-034-21

**GROUP:** 18 - Vehicle Performance

P203E and P203F Additional Diagnostic Information

2019 - 2021	(DJ)	RAM 2500 Pickup
2019 - 2021	(D2)	RAM 3500 Pickup
2019 - 2021	(DD)	RAM 3500 Cab Chassis
2019 - 2021	(DP)	RAM 4500/5500 Cab Chassis

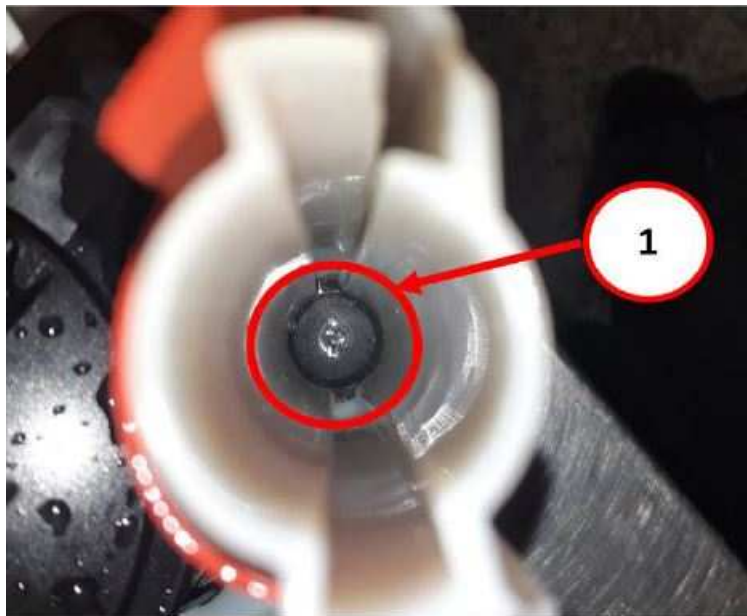
Fig. 1  
DEF Pump Assembly

Another cause of P203E and P203F is residual ice in the DEF tank. Once ambient temperatures reach approximately 12°F (-11°C), the DEF fluid in the tank will freeze. The P203E diagnostic will not run if the DEF tank, and ambient temperatures stay below 39°F (4°C). However, as the ambient temperature warms up, and the tank begins to thaw, the DEF tank may not be completely thawed by the time the P203E DTC enabling criteria are met. If there is a residual layer of ice in the tank, the ice will cause the “no echo” condition setting P203E. Vehicles are especially susceptible to having residual ice in the tank, in areas where there is a large swing in temperatures (from extreme cold to warm), in a short period of time. Additionally, if ice is covering the sensor (Fig. 1) when the temperatures are too cold to run the P203E monitor, it could lead to P203F. Even if there is sufficient fluid level in the tank.

1 - Ice In Level Sensor Focus Tube.

To correct this scenario, the DEF tank must be fully thawed out. Allow the vehicle to sit in a heated shop or garage overnight to thaw. If necessary, remove the DEF pump to drain the fluid, and remove all residual ice. Take care when removing the DEF pump to avoid damage to the pump, and heater mat. Once all the ice has been removed or thawed, follow the **P203E Drive Cycle** below.

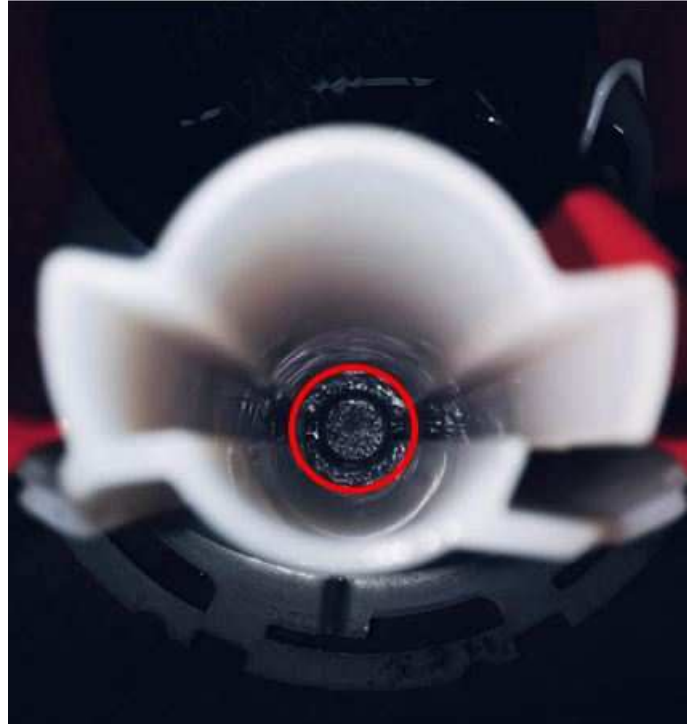
Fig. 2

Another cause of P203E and P203F is the DEF level sensor being covered in a layer or DEF crystals, or ice (Fig. 2) . Vehicles that are in extreme cold for long periods of time can start to have a buildup of DEF crystals on the bottom of the tank. When DEF tanks are completely frozen for long periods of time, evaporation will start to occur. This evaporation of the ice will leave DEF crystallization.

DEF Crystallization Buildup In Level Sensor Focus Tube

Unless the DEF fluid shows signs of contamination, crystallization that has formed in the tank, and on the pump components can be cleaned without having to replace any parts. Flush the tank, and clean the pump components using fresh DEF, or warm distilled water. In some instances, it may be necessary to remove the DEF tank, and agitate the fluid by shaking the tank. Thoroughly drain the DEF or distilled water used to clean the crystallization, and add fresh DEF. If P203E was set, follow the **P203E Drive Cycle** below.
