NUMBER: 08-024-21 REV. A

UAG, UCG and UDG Radio Enhancements

This bulletin involves updating the radio software level to 23.02.30.16

2018	(BU)	Jeep Renegade
2019 - **2020**	(BV)	Jeep Renegade

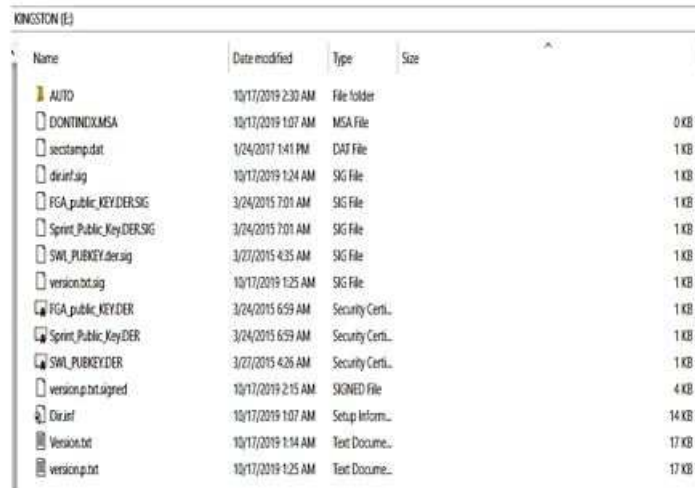
Fig. 3
Files On USB Flash Drive

6. Download extracted file to blank USB flash drive (Fig. 3) .
