NUMBER: 08-063-21

UJQ and UMQ Radio Enhancements

This bulletin involves inspecting the software level and update the radio software level to 34.2.

2018	(BU)	Jeep Renegade
2019	(BV)	Jeep Renegade

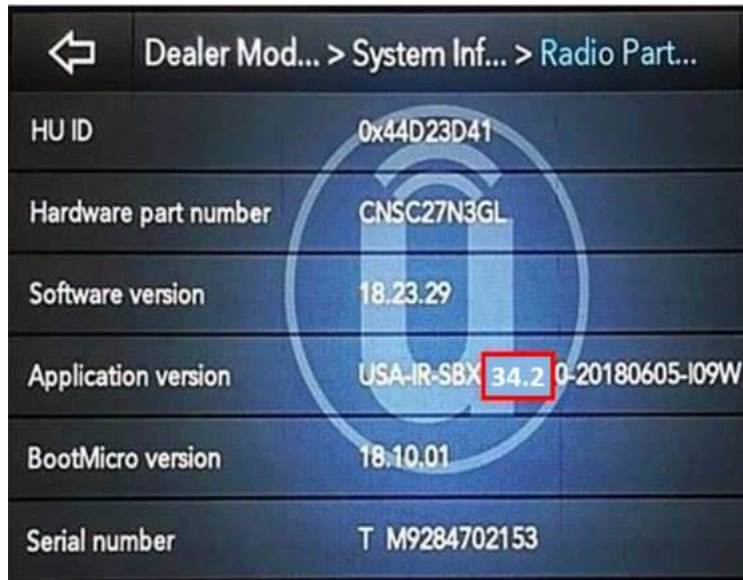
1. Verify the radio software version. Radio must be in Dealer Mode to verify by following these steps:
 - a. Press and hold both lower corners of the display screen, until the Dealer Mode screen appears (approximately seven seconds). Release screen.
 - b. Select "Radio Part Information". The software version will be listed next to "Application Version" (Fig. 1) .

Fig. 1
Radio Software Level Screen

2. What is the radio software level (Application Version) at?
 - At 34.2 or higher >>> The radio software is already up to date. Normal diagnostics should be performed.
 - Under 34.2 >>> Create a USB flash drive with 34.2 software. Proceed to [Step 1](#) of the Repair Procedure.
