Case Number: S210900002

Symptom/Vehicle Issue: Small Occasional Oil Leak, Drip, Front Of Engine

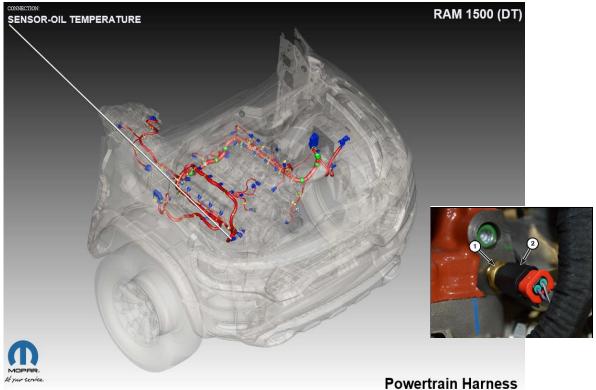
Customer Complaint/Technician Observation: Owner complains of a small oil leak appears to be at the front area. Technician can locate what appears to be a very small leak front of vehicle, cannot pinpoint where the leak is from.

Repair Procedure: Inspect oil temperature sensor as a suspect leak location, remove and tighten to specs listed in dealer connect torque specifications for this switch. No parts required.
